**CIVIL AVIATION AUTHORITY, PAKISTAN  
SAFETY & INVESTIGATION BOARD**

**SERIOUS INCIDENT: REJECT TAKE OFF  
PK-717 B-747 COMBI AP-BAK AT ISLAMABAD  
ON 21 JULY, 2003**

**Authority: Director General of Civil Aviation Authority  
Memorandum # HQCAA/1901/286/SIB dated 21-07-03  
Civil Aviation Authority, Pakistan**

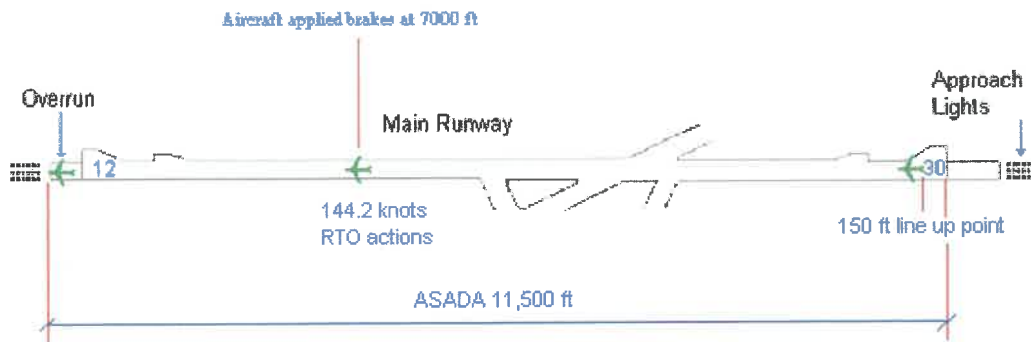
Total R/W consumed=4306+6580=10886 feet

57. If one aircraft length is subtracted from ASDA due to back track and line up on Islamabad runway 30 and one aircraft length for line-up/ at stop; then accelerate and stop distances in this incident equals to accelerate and stop distance available when abort was initiated at 144 kts CAS. At airfield limit weight for runway 30 Islamabad, as this flight was, acceleration distance to  $V_1$  is 6900 feet (60% of runway length) and remaining 4600 feet (40 % of runway length) is stopping distance. Further more, as aircraft was 3 second short of  $V_1$ , therefore, there was an additional margin of 750 feet in stop distance. Similarly, then another 600 feet were available as abort was initiated 10 kts less than  $V_1$ . It may be noted that use of reverse thrusts give 200-300' stopping distance advantage and accomplishment of abort actions in one second give 600-700 feet stopping distance advantage if RTO is initiated at  $V_1$ . In nut-shell, abort at 144kts should have been accomplished with an advantage of 1500 feet with use of Reverse Thrusts, giving the pilot 03 seconds to complete abort actions.
