# **FINAL INVESTIGATION REPORT**

## **SERIOUS INCIDENT (TCAS – RA) REPORTED BY CHINA SOUTHERN AIRLINE FLIGHT CSN5237, BOEING 777-F1B AIRCRAFT, REG NO. B2072 (GUANGZHOU – RIYADH) ON 14<sup>TH</sup> MARCH, 2024**

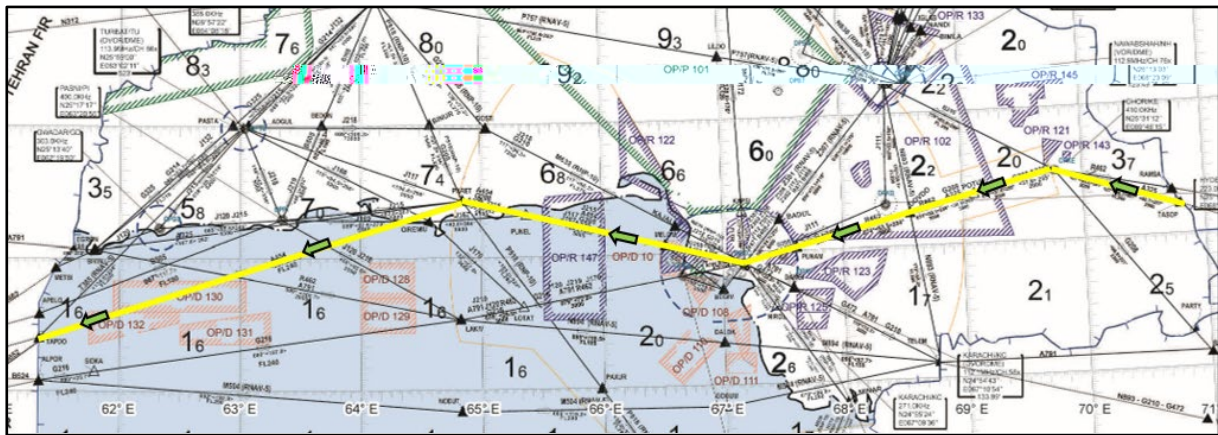
Figure 1 CSN5237 Route

1.1.1. On 14<sup>th</sup> March, 2024, China Southern Airline flight CSN5237, Boeing 777-F1B aircraft, Reg. No. B-2072 was operating from ZGGG, Guangzhou, China to OERK, Riyadh, Saudi Arabia on ATS Route A325 TASOP-KE-KC- PARET-TAPDO.

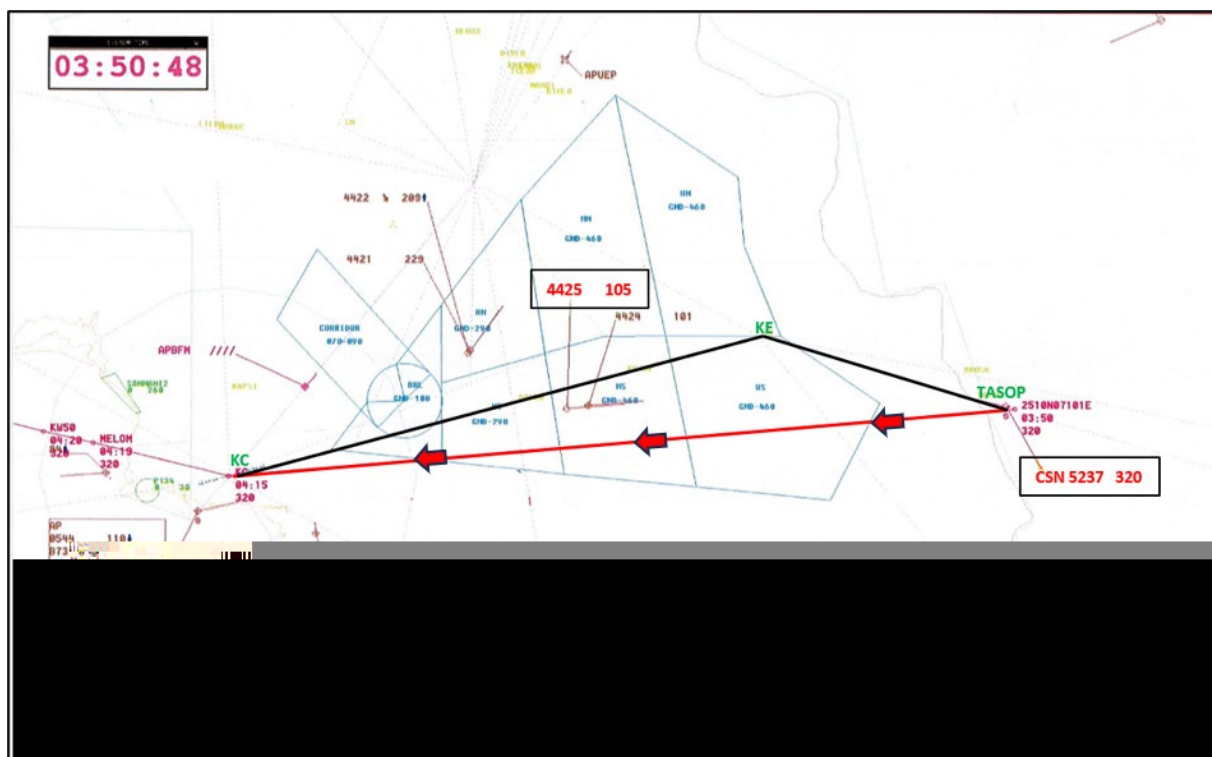
Figure 5 CSN5237 at position TASOP

2.1.6. At 03:50:55 h, CSN5237 checked position TASOP maintaining FL320 and was given direct routing to Karachi by East Surveillance Controller.
