## **FINAL INVESTIGATION REPORT**

### **SERIOUS INCIDENT OF PAKISTAN INTERNATIONAL AIRLINES FLIGHT PIA 517, ATR 72-500 AIRCRAFT, REGISTRATION NO. AP-BKY AT PANJGUR AIRPORT ON 10<sup>TH</sup> NOVEMBER, 2018**

Dated: 8<sup>th</sup> March, 2024

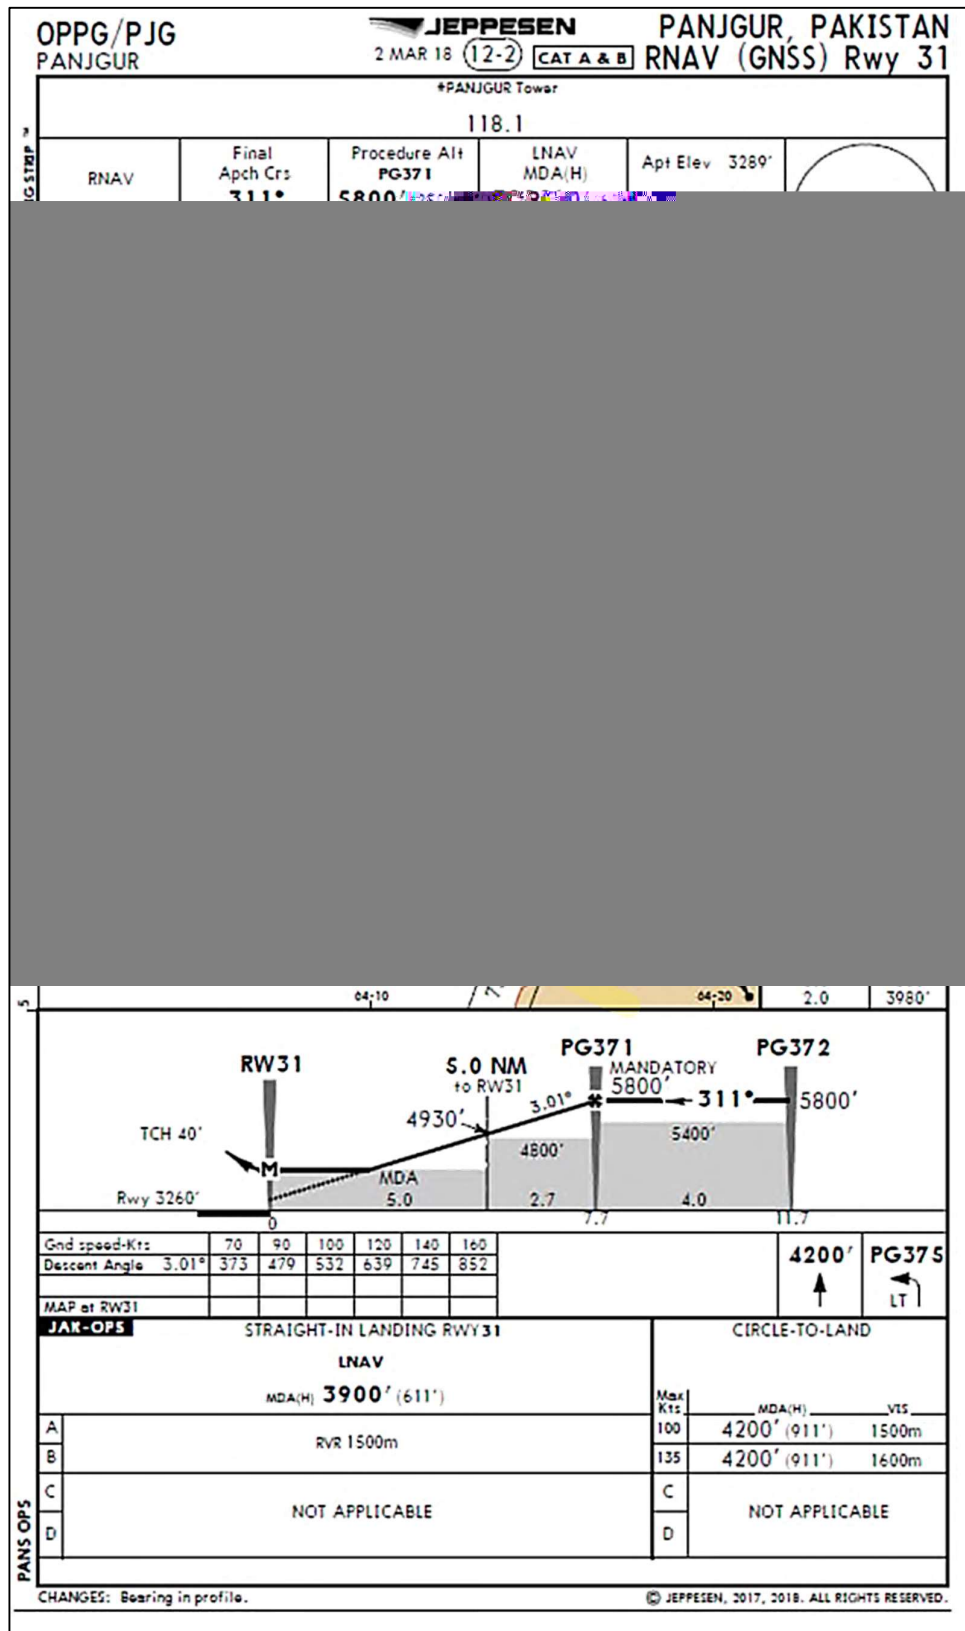
Figure 7 Instrument Approach Chart for Panjgur Airport

2.5.1 The descent for approach to Panjgur was carried out in accordance with the specified procedures for R/W 31.
