***SAFETY & INVESTIGATION BOARD  
PAKISTAN CIVIL AVIATION AUTHORITY***

**AIRCRAFT ACCIDENT INVESTIGATION REPORT**

**AP-BDX CESSNA-172 XP**

**FORCED LANDING NEAR MULTAN  
DUE TO FUEL STARVATION**

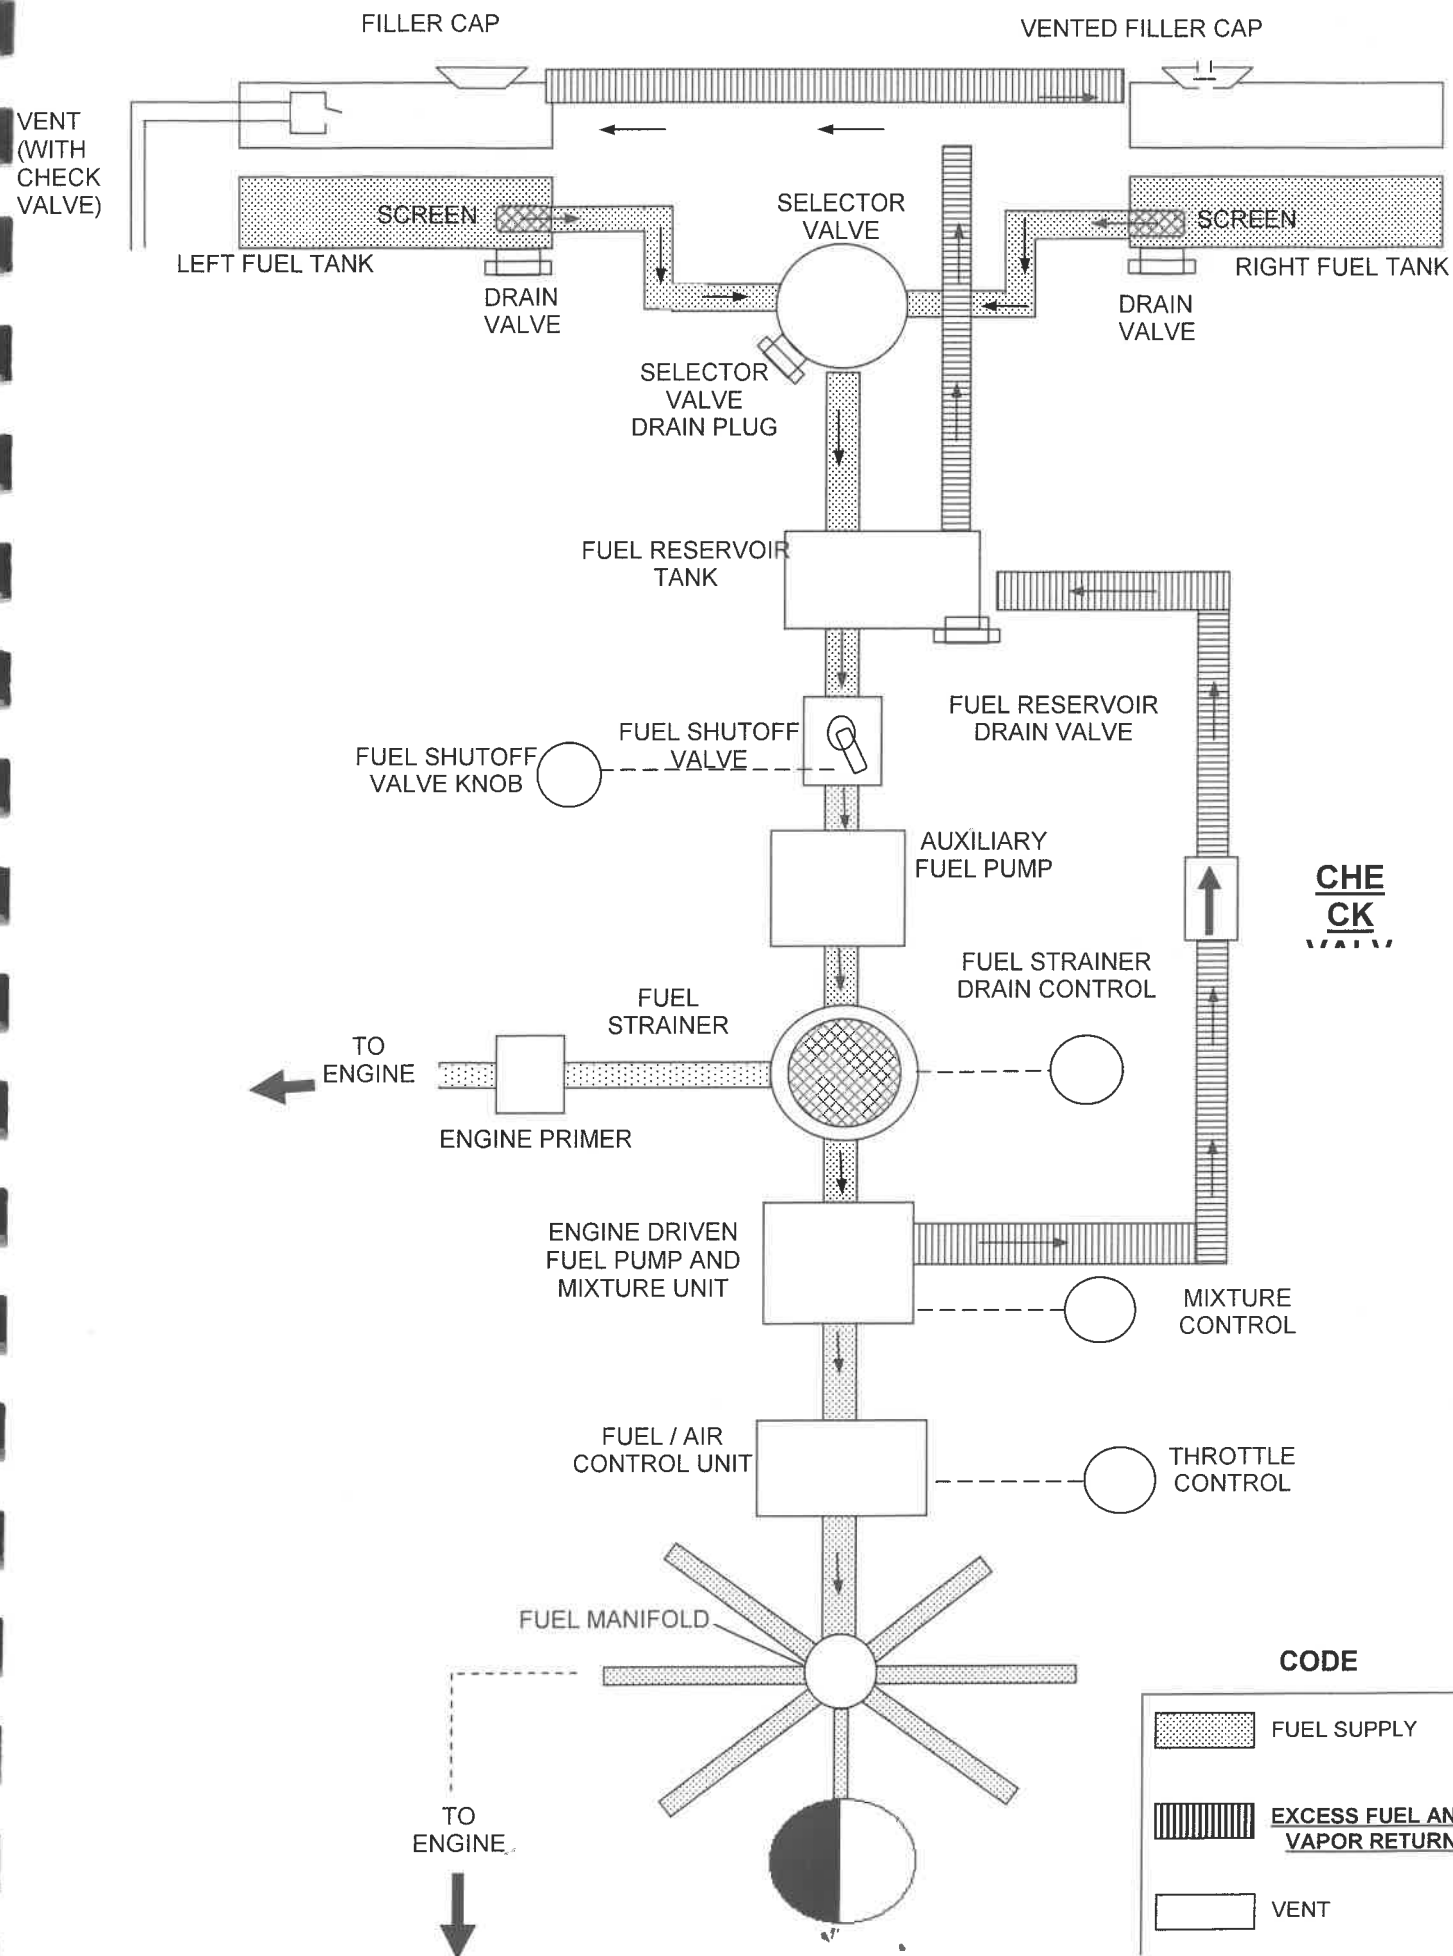
6. **FUEL SYSTEM.** This aircraft is equipped with an optional long range fuel system. The standard and long range systems are essentially the same, differing mainly in fuel tank capacity. The extended range system consists of an integral fuel bay in the inboard end of each wing. Fuel flows by gravity from an integral fuel bay area in each wing through a three-position fuel selector valve, fuel reservoir tank, fuel shutoff valve, auxiliary fuel pump, fuel strainer, engine-driven fuel pump and mixture unit, to a fuel/air control unit, which directs the flow to the engine fuel manifold and fuel flow indicator. Depending upon selector valve handle position, fuel is directed from bays to the engine through other components of the system. Positive ventilation for the systems is provided by a vent line and check valve assembly located in the left wing bay, a cross over vent line connecting the two bays. The vent line from the check valve assembly extends overboard through the lower wing skin adjacent to the left wing strut. The reservoir tank has a vapour return line from the engine and a vent line connected to the tank crossover line.
