## AIRCRAFT INCIDENT INVESTIGATION REPORT PAKISTAN CIVIL AVIATION AUTHORITY

### TCAS-RA BETWEEN PIA A-310 & AIRBLUE A-320 ON 22 DECEMBER 2004

## FINAL REPORT

### TCAS RA BETWEEN PIA 309 AND AIR BLUE 406 ON 22 DECEMBER 2004

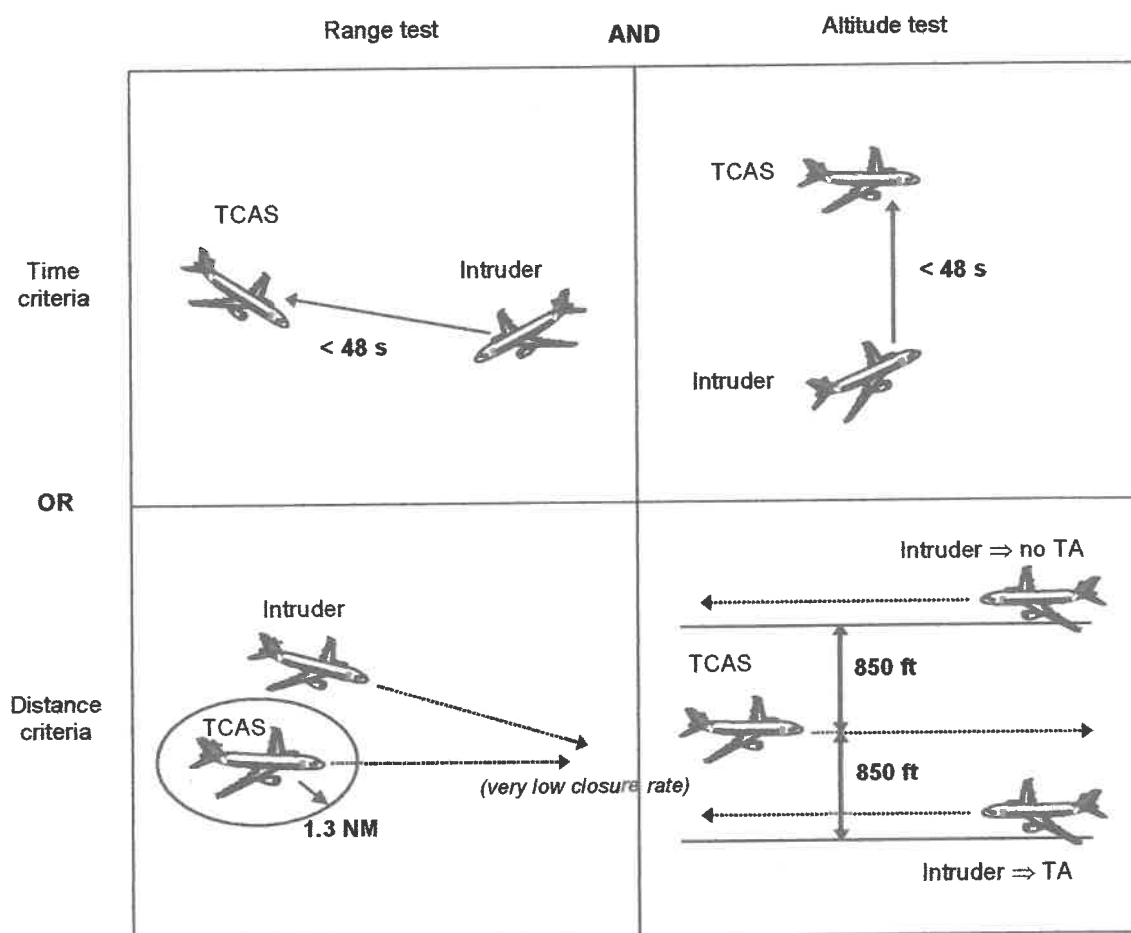
**TA triggering by TCAS II version 7.0 in RVSM airspace**

1.3.2. To address the specific case of level aircraft or aircraft with a very low relative vertical speed, the altitude test is satisfied if the relative altitude between aircraft is lower than a fixed vertical distance threshold (i.e., 850 ft for TAs and 700 ft for RAs). The following figures illustrate the range and the altitude tests, with the associated threshold values for the altitude band including the RVSM airspace.

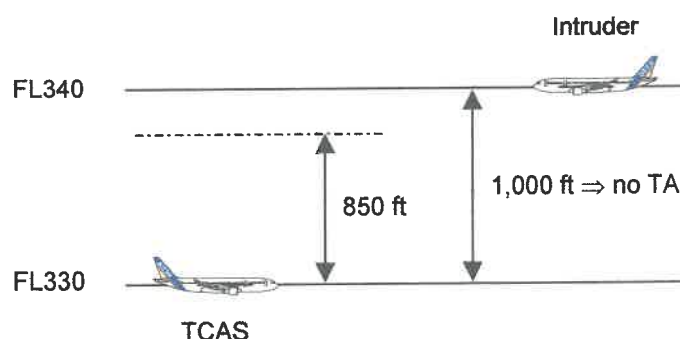
**Standard RVSM vertical separation**

1.3.4. CAS logic behaviour for an encounter with a standard vertical separation. These encounters involve level aircraft at adjacent flight levels separated by 1000 ft. Figure below illustrates this standard type of encounter for TCAS II version 7.0.

**1.3.5. Explanation for TCAS II version 7.0** In case of level aircraft, the altitude test is performed by the comparison of the relative altitude between the aircraft with an altitude threshold. If the relative altitude is lower than this threshold, the altitude test is satisfied and an advisory is triggered. The altitude threshold values for TCAS II version 7.0 are 850 ft for TAs and 700 ft for RAs. It means that when both aircraft are level at adjacent flight levels, the altitude test is not satisfied and therefore neither a TA nor an RA will be triggered.

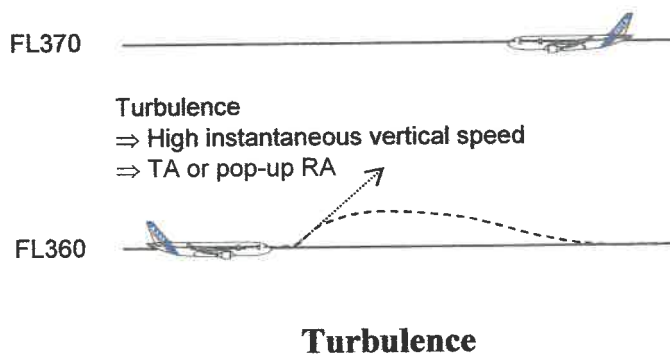
**1.3.6. TCAS logic behaviour for an encounter with a standard vertical separation and turbulences.** These encounters involve an aircraft experiencing an atmospheric or a vortex turbulence that makes it deviate very suddenly with a high instantaneous vertical speed and an important acceleration towards another aircraft on an adjacent flight level. As a consequence there is a high vertical convergence and pop-up RAs can be triggered on-board both aircraft. Figure below illustrates this type of encounter in which the lower aircraft experiences a turbulence that makes it suddenly climb towards the other aircraft.

TCAS II is provided every second with the altitude of the own aircraft, from which it computes a vertical speed. If the aircraft experiences severe turbulence that makes it deviate very suddenly towards another aircraft, the altitude varies with an important acceleration. Therefore, TCAS II computes a high vertical speed. Therefore when it performs the altitude test with this high vertical speed, the time to reach co-altitude is lower than the time threshold. The altitude test is thus satisfied and an advisory is triggered.
