# **FINAL INVESTIGATION REPORT**

**ACCIDENT OF M/S SHAHEEN AIR FLYING TRAINING  
SCHOOL CESSNA-162 AIRCRAFT, REG # AP-ZBQ ON  
24<sup>TH</sup> FEBRUARY, 2017 AT FAISALABAD**

### ACCIDENT OF M/S SHAHEEN AIR FLYING TRAINING SCHOOL CESSNA-162 AIRCRAFT, REG # AP-ZBQ ON 24<sup>TH</sup> FEBRUARY, 2017 AT FAISALABAD

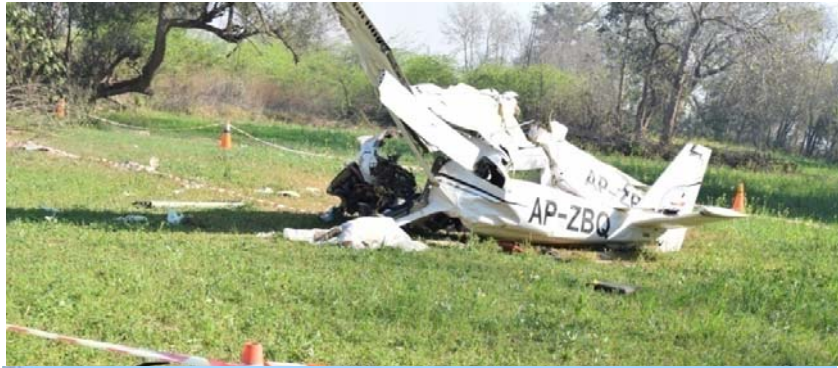
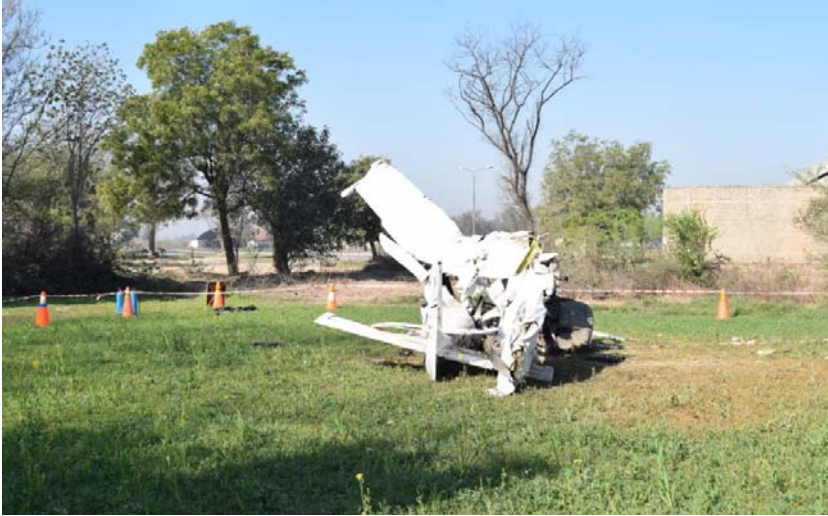
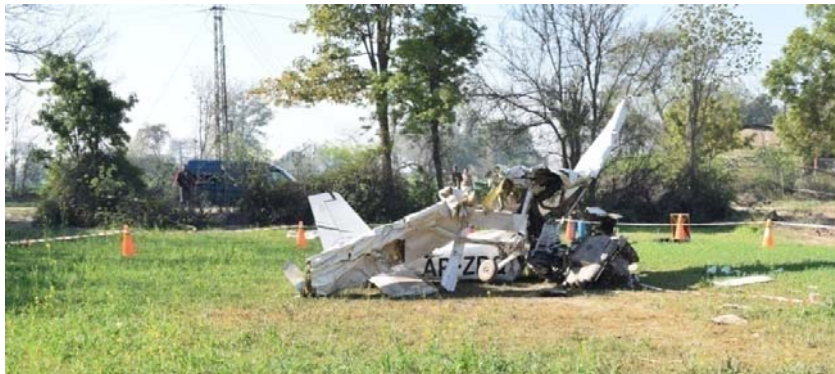
2.2.3.1 Right wing was badly damaged beside aircraft nose as it seems to have hit the ground first. Tail section of the aircraft was in good shape and so were the horizontal stabilizers and the rudder.
