## FINAL INVESTIGATION REPORT

**INVESTIGATION INTO SERIOUS INCIDENT OF  
M/S SHAHEEN AIR INTERNATIONAL FLIGHT # NL-148,  
(SECTOR KHI-LHE) B-737-400 AIRCRAFT, REG # AP-BJN  
(BIRD HIT AT SHORT FINALS AND RUNWAY  
EXCURSION AFTER LANDING AT LAHORE  
ON 30<sup>TH</sup> DECEMBER 2014**

### SERIOUS INCIDENT OF M/S SHAHEEN AIR INT'L (SAI) FLIGHT NL-148 (SECTOR KHI-LHE), B737-400 AIRCRAFT, REG # AP-BJN AT AIIAP, LAHORE ON 30<sup>TH</sup> DECEMBER, 2014

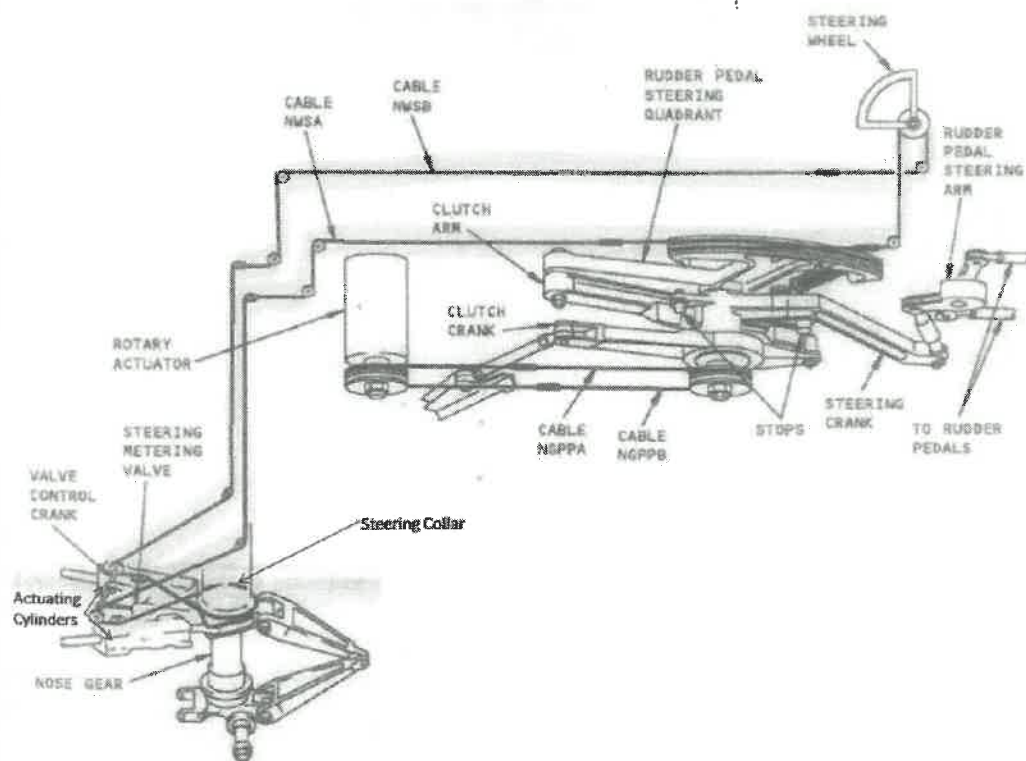
1.21. The steering system cables NWSA and NWSB are finally connected at the steering collar on the NLG. Movement of the steering wheel or rudder pedal (with clutch mechanism engaged) puts one of cable under tension. The under tension cable through a "Valve Control Crank" moves the control piston in the steering metering valve. Steering metering valve directs hydraulic fluid to the actuating cylinder. The actuating cylinder is further connected to the steering collar which swivels the nose wheel. As the desired amount of turn is reached the movement of steering collar releases the cable tension and swiveled position of the nose wheel is thus maintained. When steering wheel is released, it returns to its neutral position, and the mechanism works again in similar manner to bring the nose wheel to neutral position.

Nose wheel steering system, schematic diagram

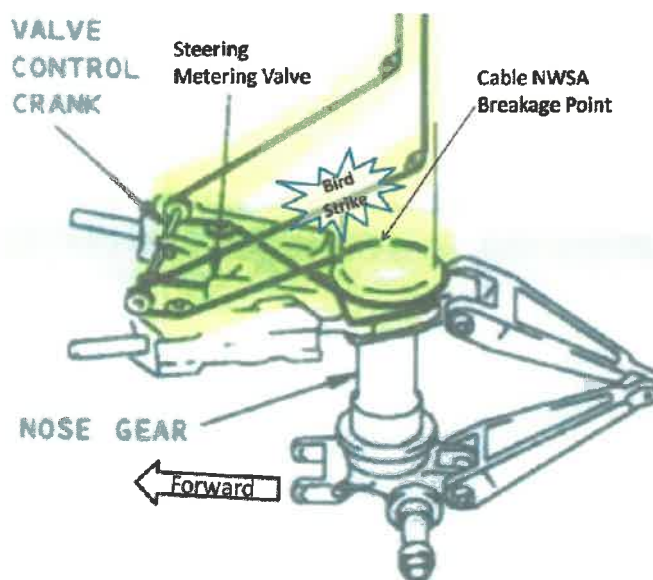
2.2.6. The bird strike took place on left side of the nose leg top fork. The left side nose wheel system steering cable (NWSA) was found fractured approximately at a point where it starts its routing on the steering collar. A portion of the cable was found pulled out from the lower side pulleys mechanism (closer to steering metering valve). The upper side of the cable was dislodged from the pulley groove and was found stuck between the pulley guard and the pulley. The position of the cable indicated that the bird most probably struck directly on the cable.

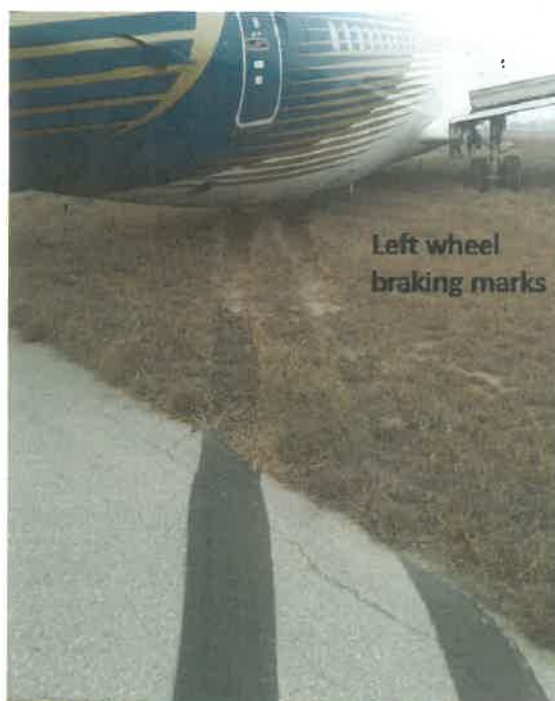
Tire marks before leaving the runway (viewing backward)
