INVESTIGATION REPORT INTO FATAL ACCIDENT TO GOVERNOR  
OF BALUCHISTAN CESSNA-421 AIRCRAFT BEARING  
NATIONALITY AND REGISTRATION MARKS AP-AYQ  
WHICH OCCURRED ON 6-7-84 NEAR MANKERA  
AT 170608 P.S.T.

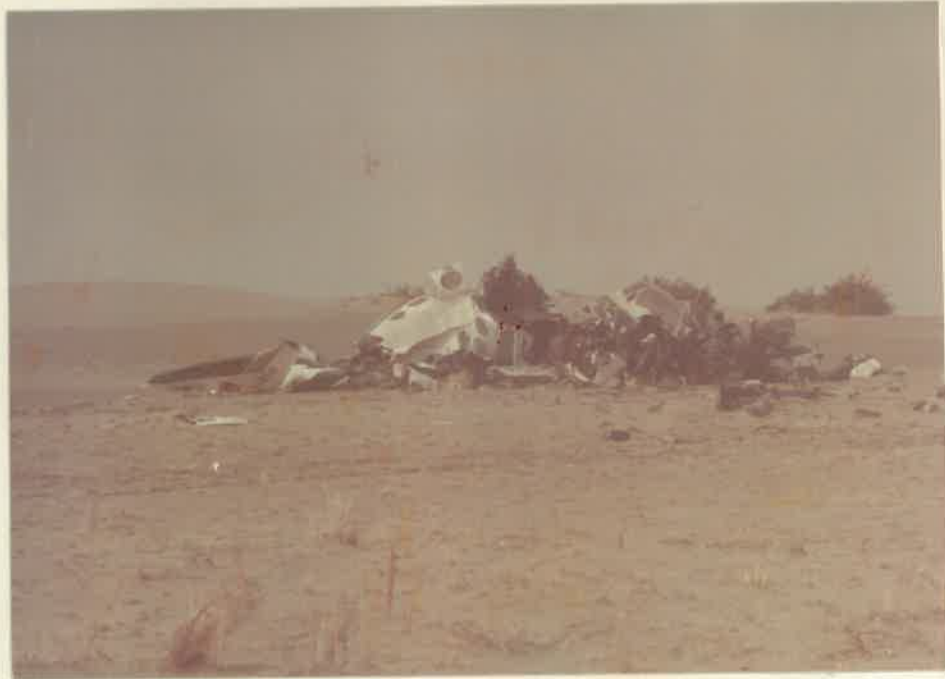
APP.'AN.7/B'

Right engine and main wreckage seen from the direction opposite the travel path of the wreckage. Village from where people came for rescue can also be seen in the back-ground.
