**PAKISTAN CIVIL AVIATION AUTHORITY**  
**(SAFETY INVESTIGATION BOARD)**

**FINAL REPORT**

**M/S SCHON AIR CESSNA-172D REG # AP-BHT**  
**FORCED LANDING AT MALIR CANTT NEAR JIAP KARACHI**  
**ON 10<sup>th</sup> DECEMBER, 2012**

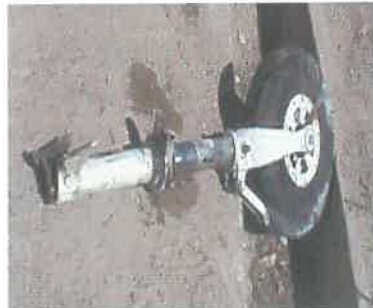
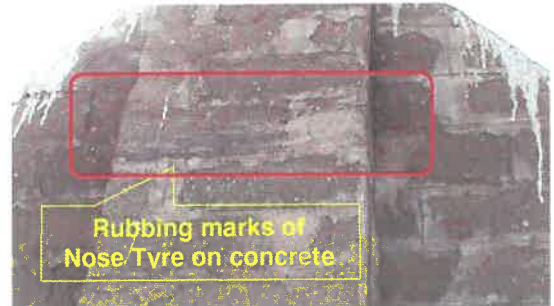
- 1.12.1.1. Wreckage was confined to an area of about 170x40 sq ft.
- 1.12.1.2. The aircraft was mainly intact despite severe structural damage to its right wing, horizontal and vertical stabilizers.
- 1.12.1.3. The nose landing gear had broken and was lying 140 ft behind the aircraft. It broke due to impacting with the concrete wall.

- 1.12.1.4. Carburettor of the engine broke off from its housing after the engine rubbed against the ground due to nose landing gear breakage. It was found lying near left wing about 4 ft from the engine.

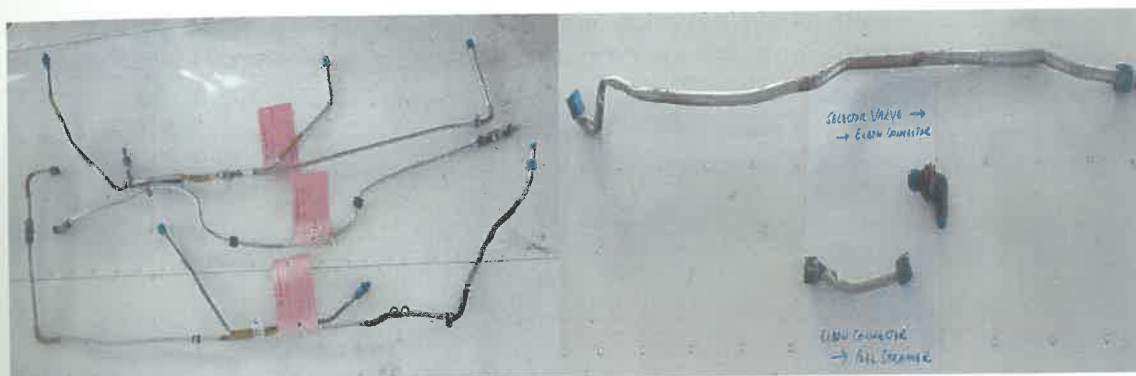
**Pipes of fuel supply lines from Wing Tank to Carburetor**

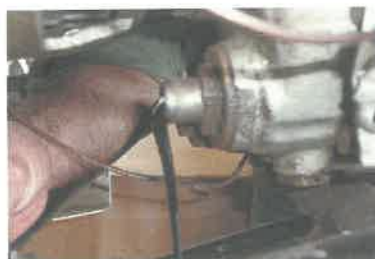
2.2.9.4. **Oil Starvation.** As already mentioned above, quite a good quantity of oil was found splashed on ground under the engine at the crash site. Later on, once the oil filter was removed in the maintenance hangar, large quantity of oil was found available in the oil sump which was collected for subsequent lab test. Similarly, the filter was also found not clogged and in a satisfactory condition. Therefore, the possibility of oil starvation due to insufficient oil quantity, leakage in oil system or clogging of oil filter was not a likely cause. See figures below.

**Oil being collected from Oil Sump**

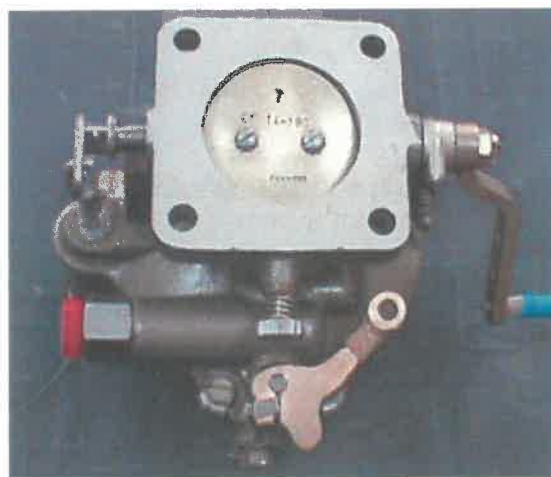
A serviceable carburettor, showing state of throttle lever and piston when the butterfly valve is at fully closed position

2.2.9.11. From the comparison it became evident that Butterfly valve was in "Fully Open" position (throttle full open) at the time of impact. Due to rubbing against ground its upper half suffered severe scratches and was bent in the direction of closed position, but the lower half remained in open position.
