## AIRCRAFT ACCIDENT INVESTIGATION REPORT

**RUNWAY EXCURSION ACCIDENT  
FOKKER-27 REG # AP-AUR AT CHITRAL ON 16 JUNE, 2004  
PAKISTAN INTERNATIONAL AIRLINE**

*Safety & Investigation Board  
Headquarters Civil Aviation Authority*

**ACCIDENT TO M/S PIAC F-27 REG # AP-AUR AT CHITRAL  
AIRPORT ON 16 JUNE 2004**

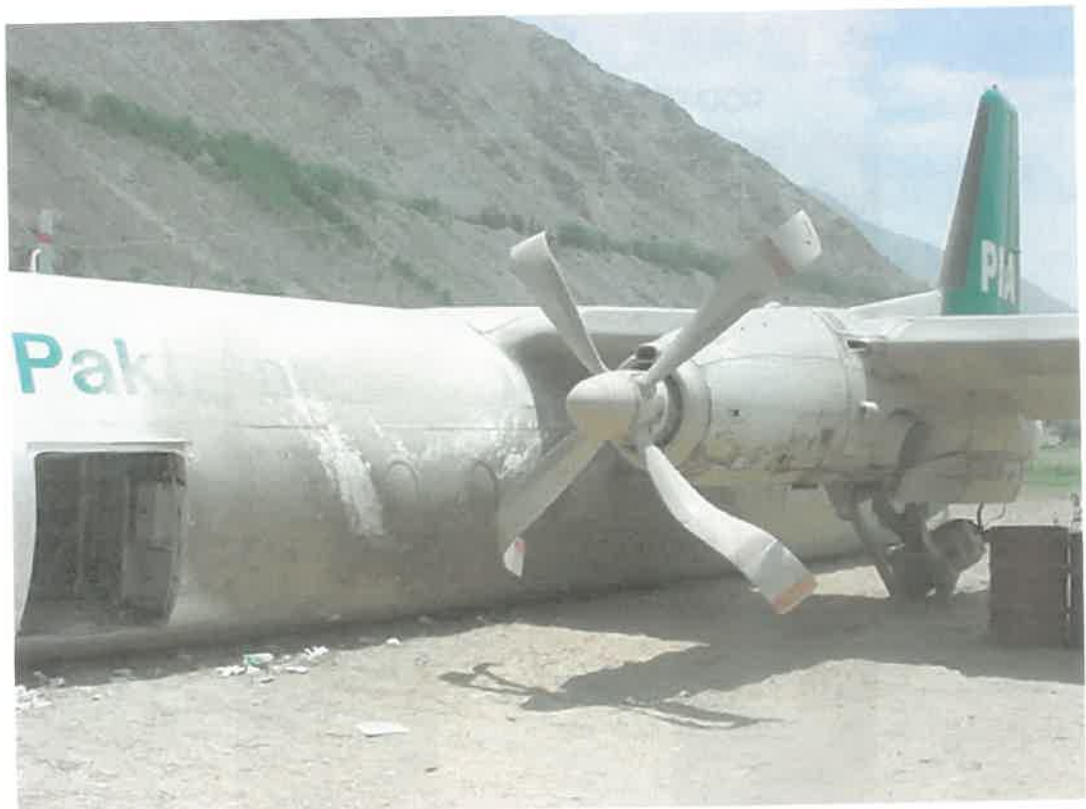
- a. Major structural damage.
- b. Left propeller and internal engine damage.
- c. All under carriages broken.

LANDING GEARS BROKEN & ENGINE PROPELLER DAMAGE

landing gears broke and were found 164 and 198 feet (left & right respectively) behind the point where the aircraft finally stopped. The left propeller touched the ground and was damaged. Other damages on the aircraft are listed under aircraft damages. Tyre- marks and other relevant impact / wreckage informations are given in the sketches Appendix 'H'.
