# **FINAL INVESTIGATION REPORT**

## **SERIOUS INCIDENT OF GULF AIR FLIGHT GFA 770 BOEING 787-9 AIRCRAFT REG. NO. A9C-FF AT ISLAMABAD ON 02-06-2021**

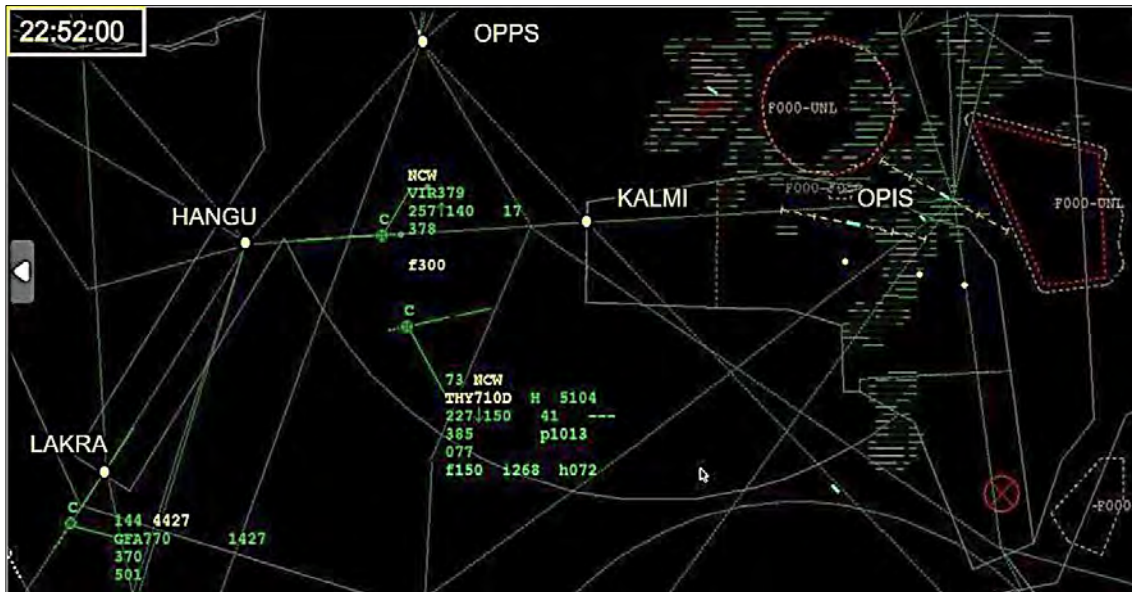
1.1.3. At 22:52:00 h, GFA 770 came in contact with Area Control Islamabad while approaching position LAKRA and descending Flight Level (FL) 290. Aircraft was identified and given arrival clearance with descent to FL150.

Figure 1 GFA 770 came in contact with Area Control Islamabad

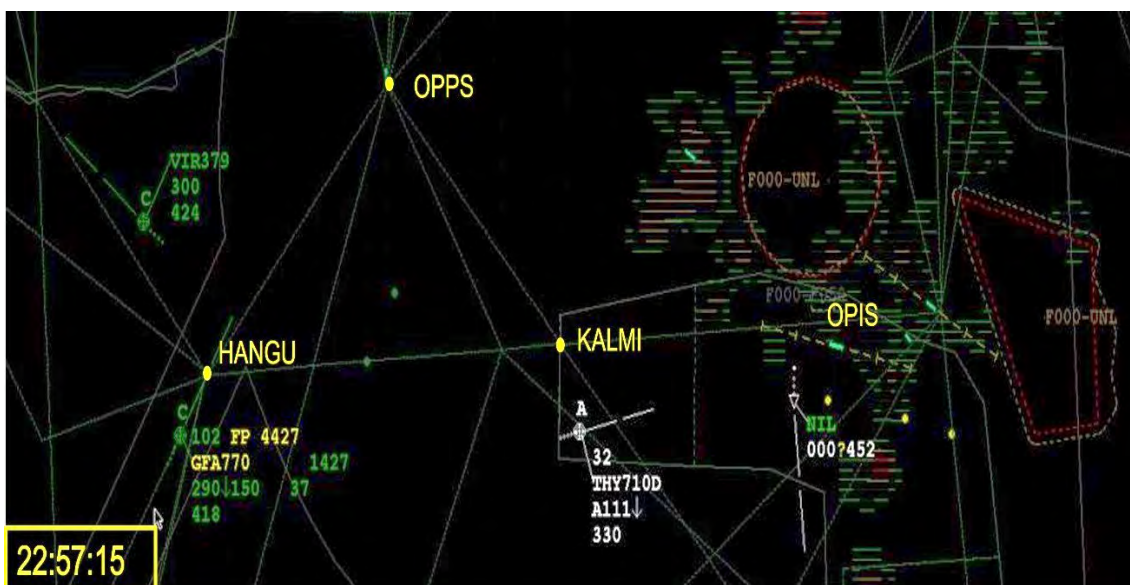
1.1.5. At 22:57:15 h, approaching South of HANGU, aircraft requested to maintain heading 060° for 10 NM to avoid flying into inclement weather. Weather deviation was approved by Area Radar Controller. The weather reported at that time was Thunderstorm / Rain at IIAP, Islamabad and surrounding areas.

Figure 2 Weather at IIAP, Islamabad and Surrounding Areas

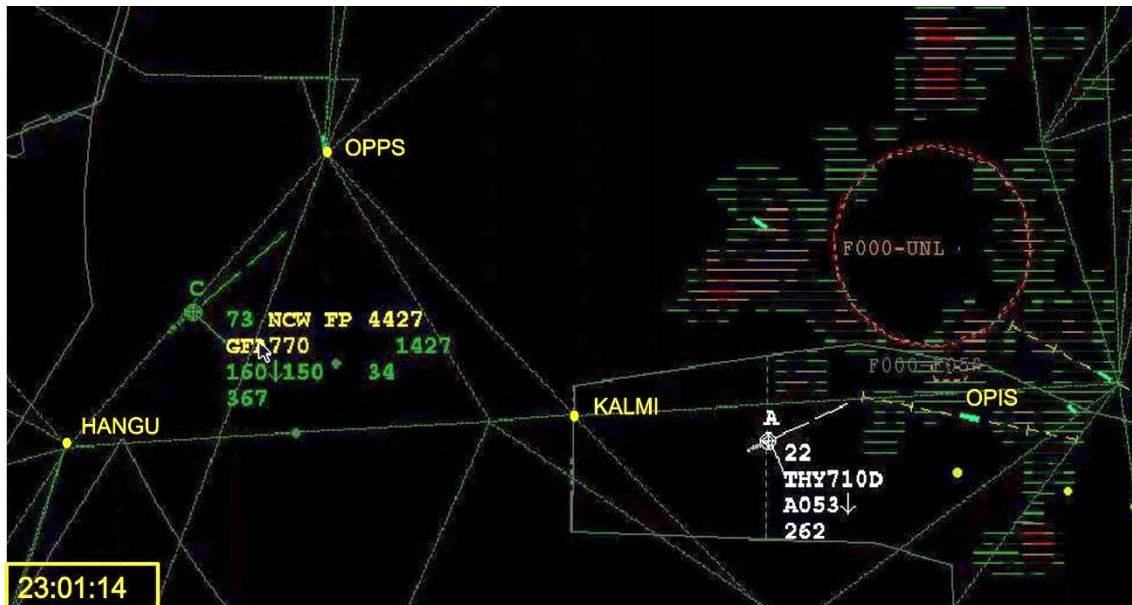
1.1.6. At 23:01:14 h, GFA 770 requested for further descent. Area Control Islamabad inquired “how long you will maintain this heading”. GFA 770 informed that they are turning right heading 060°. GFA 770 was given descent 9,000 ft on QNH 1006 Hectopascal (hPa) (QNH for IIAP, Islamabad). Same was acknowledged by GFA 770.

Figure 3 GFA 770 given descent to 9,000 ft

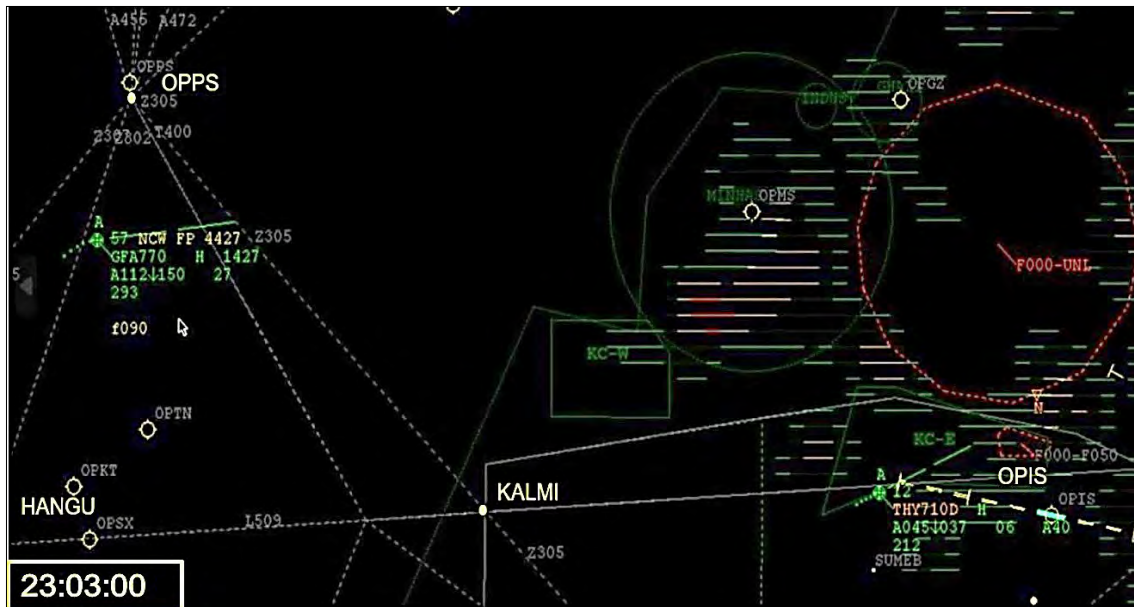
1.1.9. At 23:03:00 h, GFA 770 informed turning right heading 080°. Approach Control Islamabad inquired “for how long you will maintain heading 080°”. GFA 770 replied that they would be maintaining heading for another 05 miles and informed Approach Control Islamabad that they need to descend otherwise they will enter into weather at this level.

1.1.10. Approach Control Islamabad informed GFA 770 that on present heading they will be proceeding towards hilly terrain and they have to turn right for descent.

Figure 5 GFA 770 turning right heading 080°

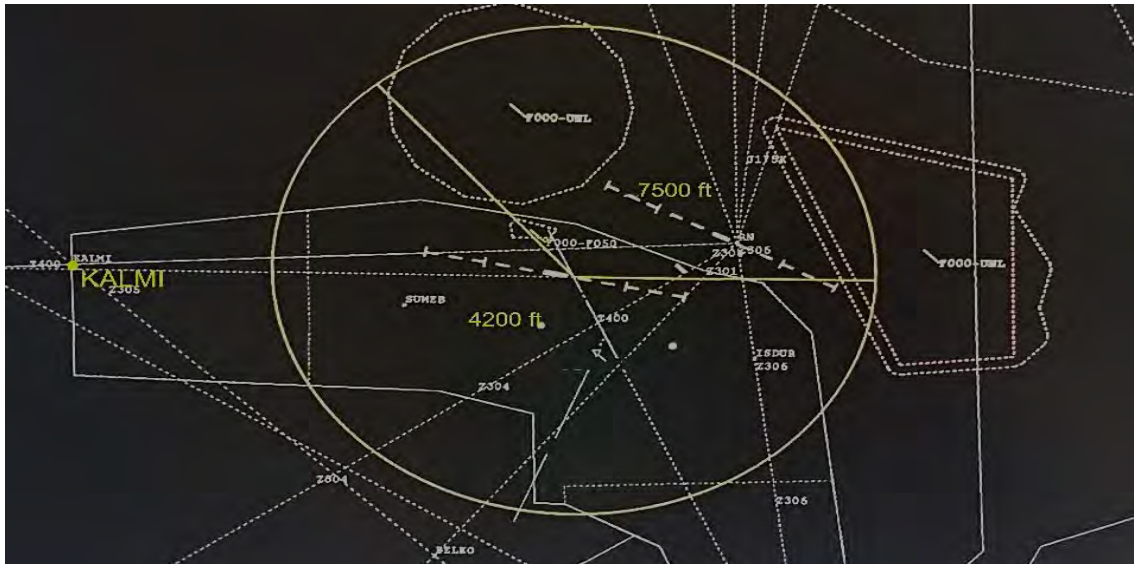
Figure 16 MSA around BTR / VOR IIAP, Islamabad in SI-ATM Radar Display

- (d) Flight crew wrongly selected MSA of 4,200 ft from the Approach chart (25 NM from IIAP) instead of considering Grid MORA as they were distracted due to the weather conditions. Lack of Situational Awareness by both flight crew resulted in overlooking sector AMA of 10,300 ft.

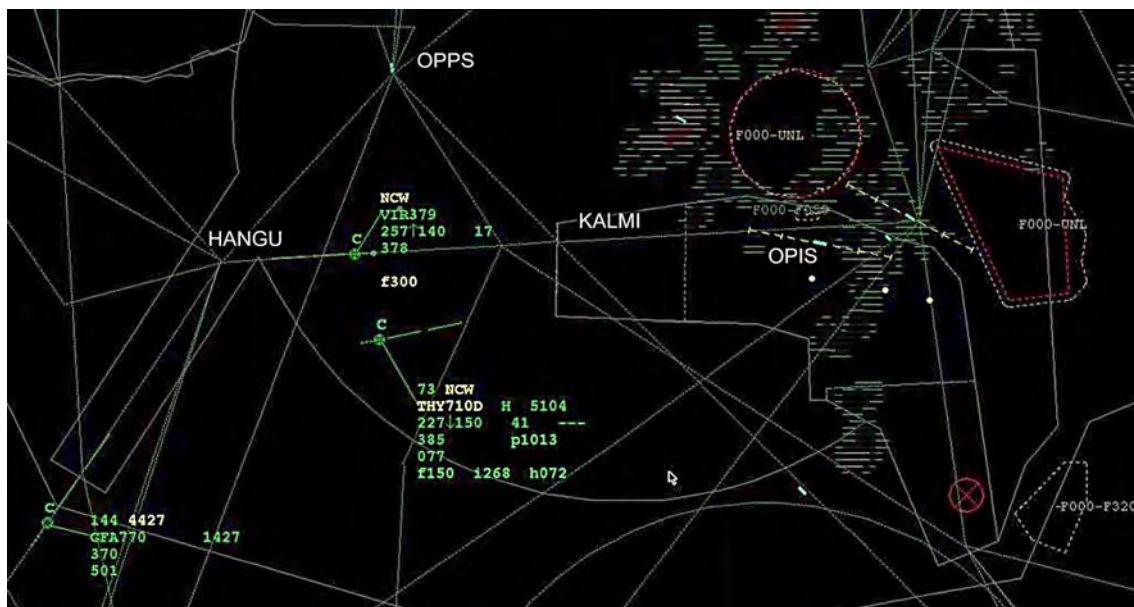
(d) The arrival ahead of GFA 770 was THY710D, which was vectored South of HANGU for traffic management and thereafter for ILS Approach R/W 10R. At the same time another flight bearing call sign VIR 379 departed from IIAP, Islamabad and was following standard ATS route for HANGU.

Figure 18 Arrival ahead of GFA 770

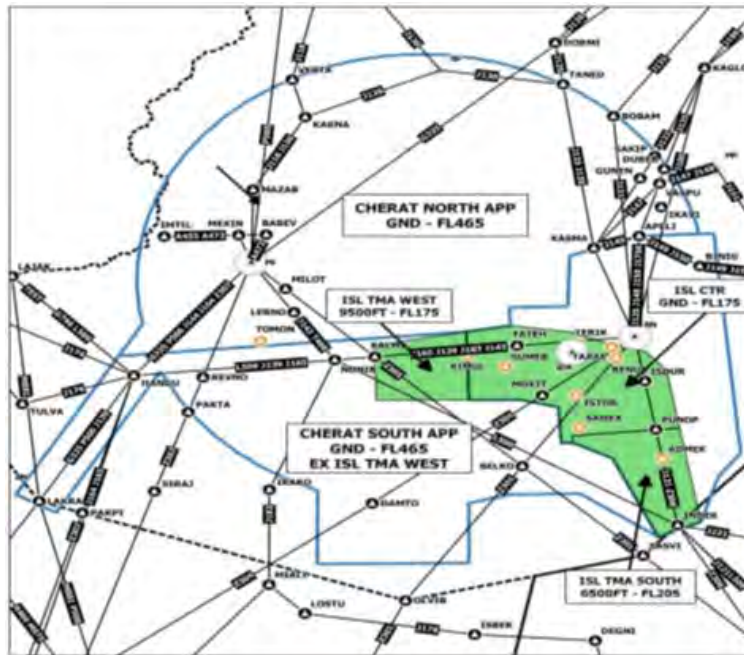
Figure 22 Cherat Control Zone

(c) Though the distribution of airspace has been clearly demarcated and mentioned in the AIP and SATI, IIAP, Islamabad however mutually agreed LOAs between Area control Islamabad and Cherat Approach South / North and between Approach Control Islamabad and Cherat Approach South units were not available.
