## **FINAL INVESTIGATION REPORT**

### **SERIOUS INCIDENT (TCAS – RA) BETWEEN PIAC FLIGHT PIA303, A320-214 AIRCRAFT, REG. NO. AP-BOL (OPLA - OPKC) AND MILITARY AIRCRAFT ON 04-03-2022**

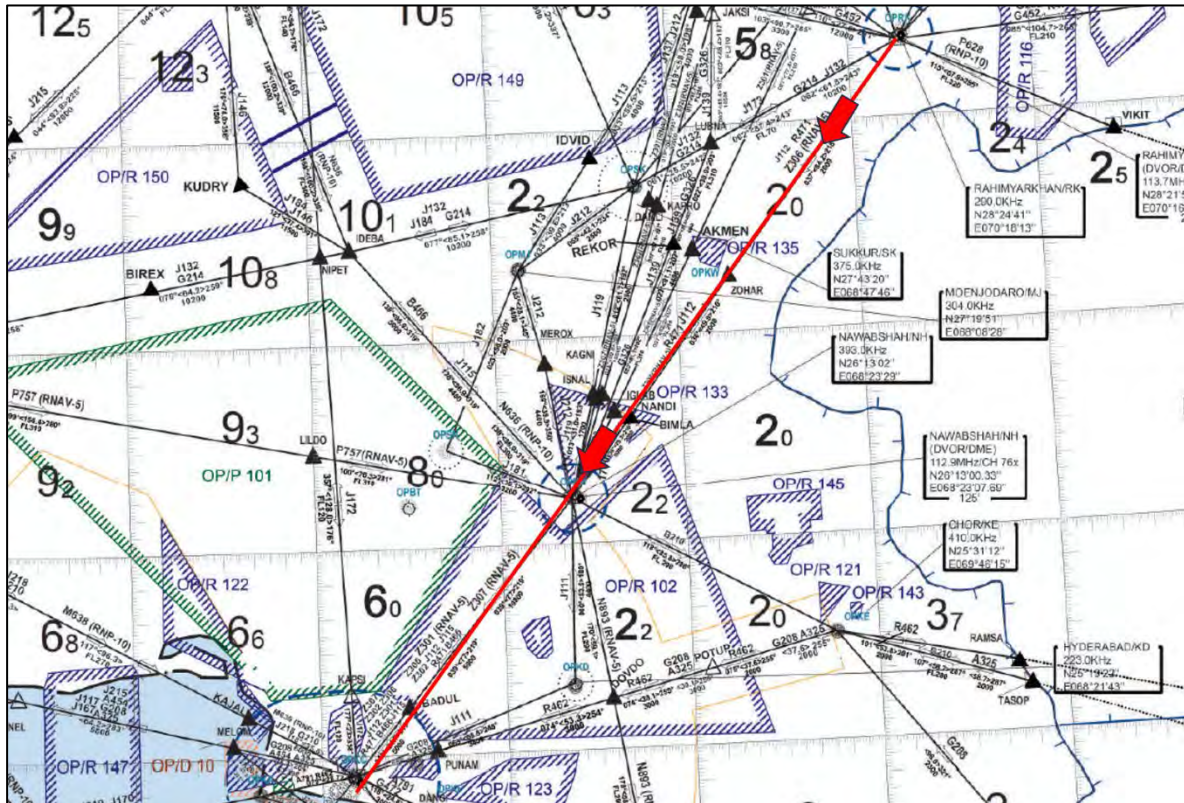
Figure 1 PIA303 Route

1.1.1. On 04<sup>th</sup> March, 2022, PIA Flight PIA303, A320 aircraft, Reg. No. AP-BOL was operating from OPLA, Lahore, Pakistan to OPKC, Karachi, Pakistan on ATS route J112 – NSH – KC maintaining FL380.
