**REPORT ON THE ACCIDENT  
OF  
PAKISTAN INTERNATIONAL AIRLINES A300  
FLIGHT PK268 (AP-BCP)  
ON  
28 SEPTEMBER 1992**

**His Majesty's Government of Nepal**  
*27 June* **1993**

**This report has been published by His Majesty's Government of Nepal as submitted by the Commission for the Accident Investigation of PK 268 Airbus, established for the purpose of advancing aviation safety, in accordance with Annex 13 to the Convention on International Civil Aviation.**

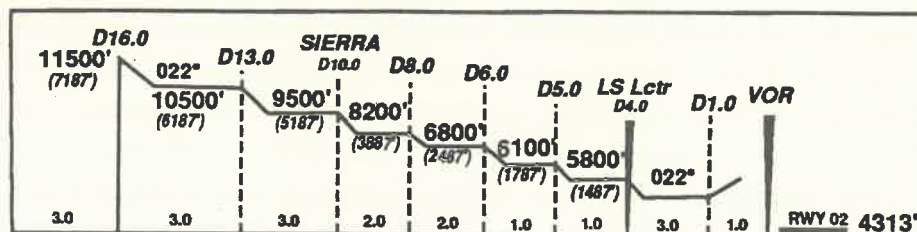
<sup>2</sup> Not an exact copy of the Jeppesen chart altitude profile.

At 16 DME the crew were 'one altitude step' ahead of the correct profile. If this situation had persisted, the crew would have been aiming to be at 9,500 feet at 13 DME, 8,200 feet at 10 DME and 6,800 feet at 8 DME. The correct profile, the misinterpreted or 'one step ahead' profile, and the aircraft's actual flight profile are shown on the diagram below. From the diagram it is clear that the aircraft passed through 9,500 feet at 13 DME but then continued below the 'one step ahead' profile until impact.
