# FINAL INVESTIGATION REPORT

SERIOUS INCIDENT OF M/S PIAC FLIGHT NO. PK451  
(SECTOR ISB – SKD) A-320 AIRCRAFT REG NO. AP-BLA  
AT BBIAP, ISLAMABAD ON 08<sup>TH</sup> AUGUST, 2016

## FINAL REPORT

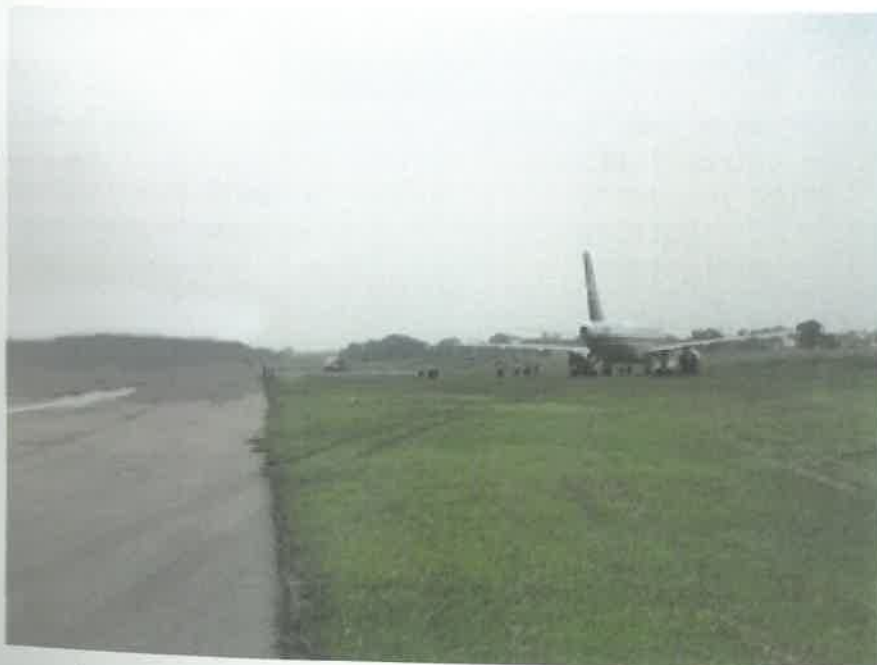
- 1.1 **History of the Flight.** On 08<sup>th</sup> August, 2016, M/s PIAC Flight PK451 of (Airbus 320 Reg. No. AP-BLA) was a scheduled passenger flight from Islamabad to Skardu. After taxi out, the aircraft returned to ramp due to green hydraulic and brakes problem. The necessary rectification was done and the aircraft was declared serviceable for flight. The subsequent start up and taxi out remained uneventful, however, after takeoff, when the aircraft was climbing, the green hydraulic system fault appeared again. The aircrew decided to proceed back to Islamabad. After landing, the aircraft departed the runway after travelling approximately 8500 feet from beginning of runway 30 towards right side at 50 kts ingesting one of the PAPI lights by No. 2 engine.

- 1.2 **Injuries to Persons.** There were no injuries to any person during the incident.
- 1.3 **Damage to Aircraft.** No. 2 engine received substantial damage due to hitting / ingestion of PAPI light. There was no other damage to the aircraft.
