## ***AIRCRAFT INCIDENT REPORT*** ***7/97***

### ***REPORT ON THE INCIDENT TO*** ***PAKISTAN INTERNATIONAL AIRLINE*** ***B747-200*** ***AT DUBAI INTERNATIONAL AIRPORT*** ***ON 28 DECEMBER, 1997***

### ***REPORT ON THE INCIDENT TO PAKISTAN INTERNATIONAL AIRLINE B747-200 AT DUBAI INTERNATIONAL AIRPORT ON 28 DECEMBER, 1997***

**REPORT DATE: 01 May, 1998**

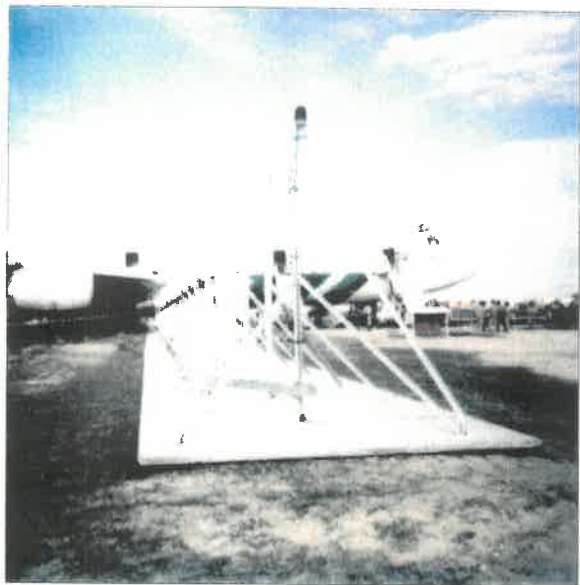
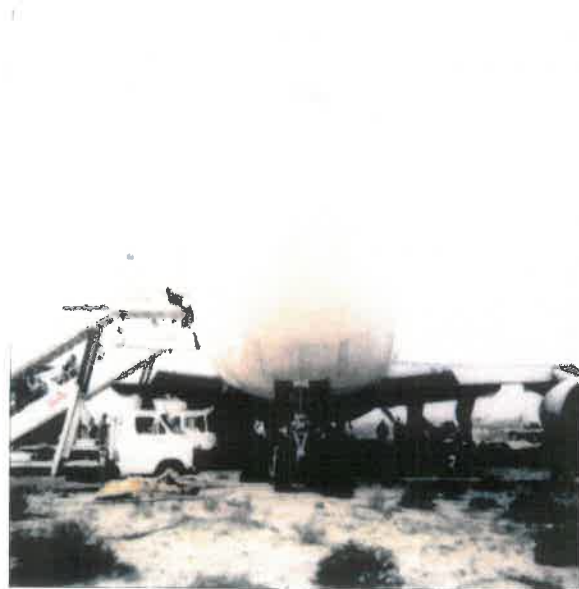
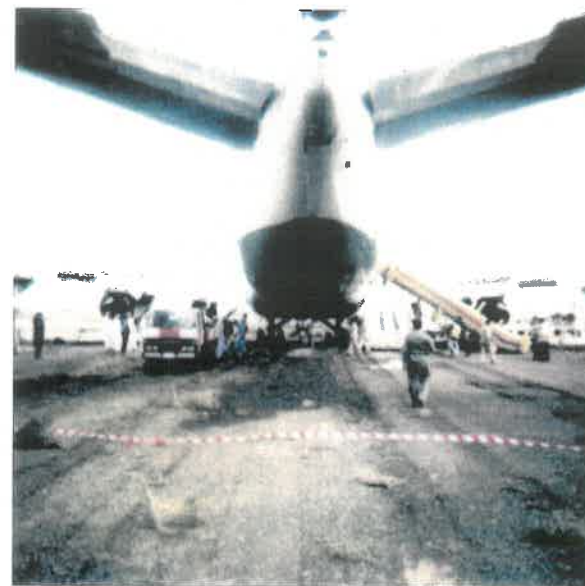
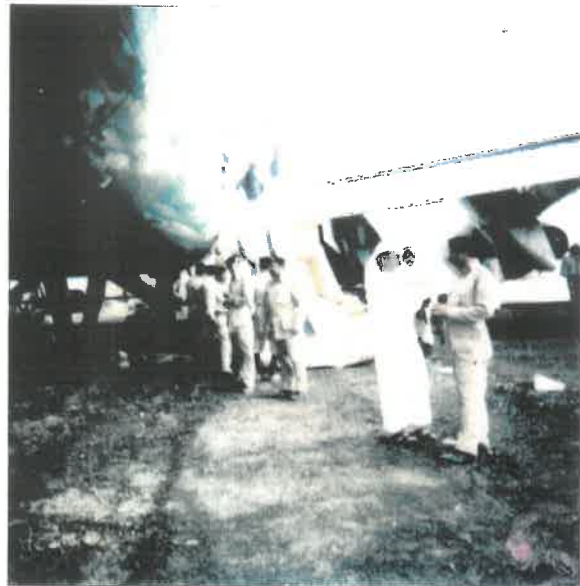
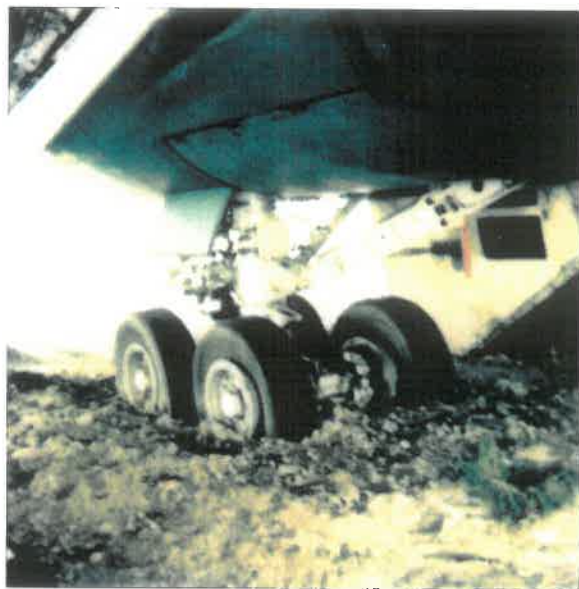
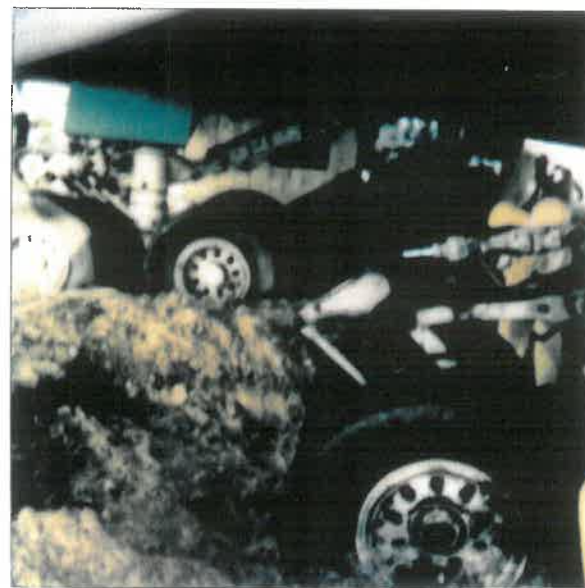
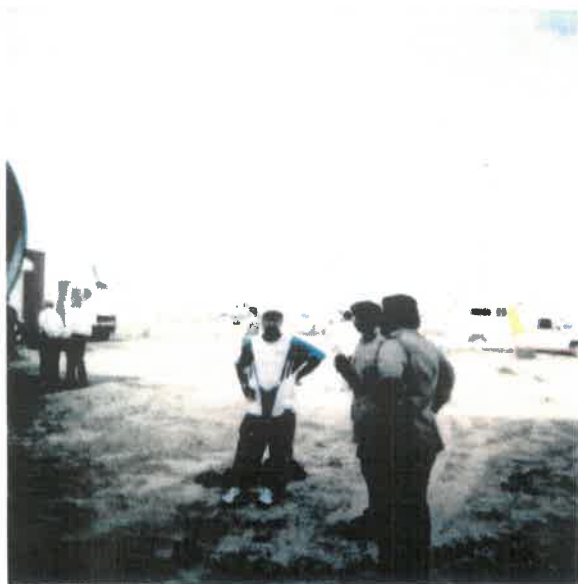
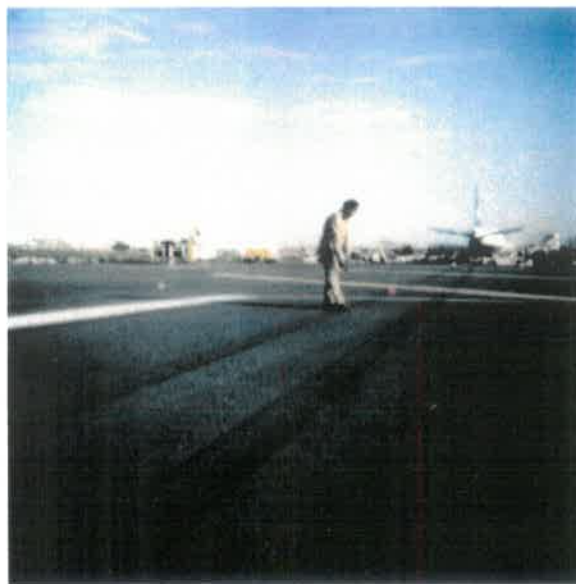
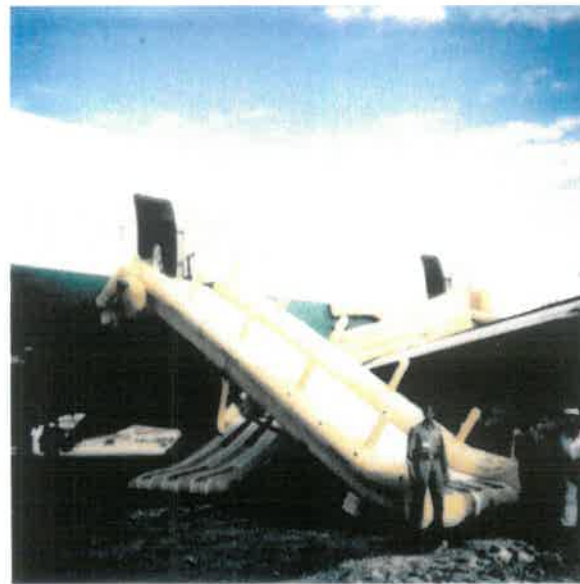
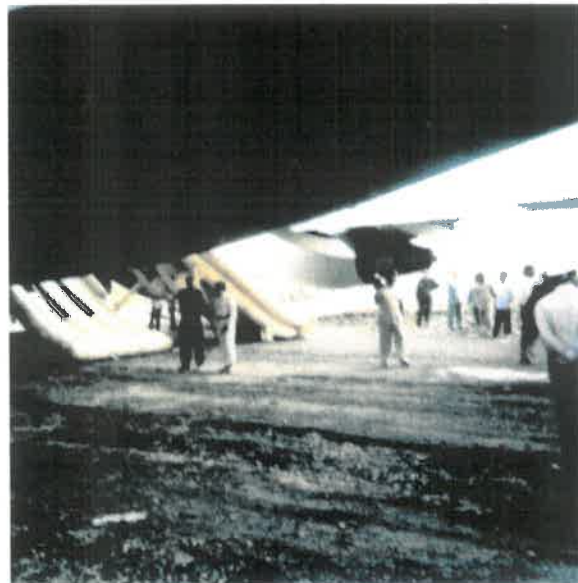
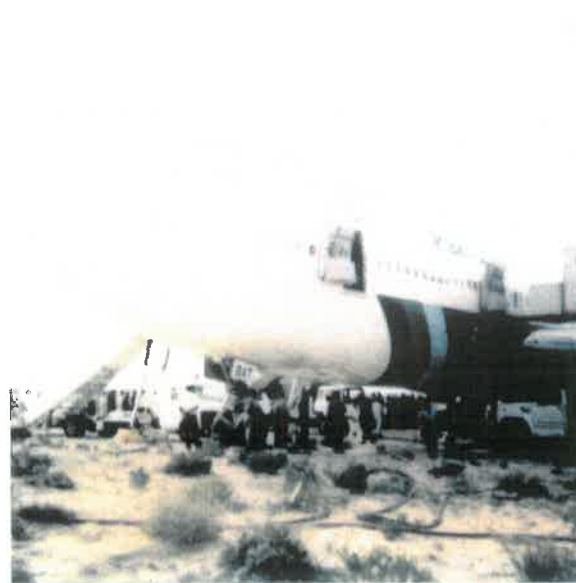
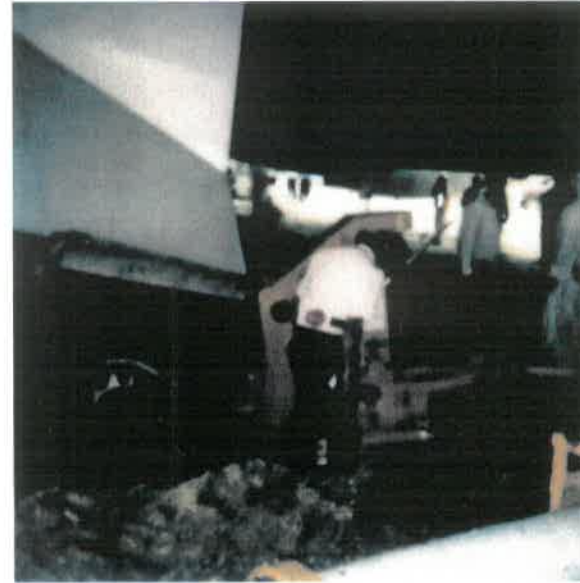
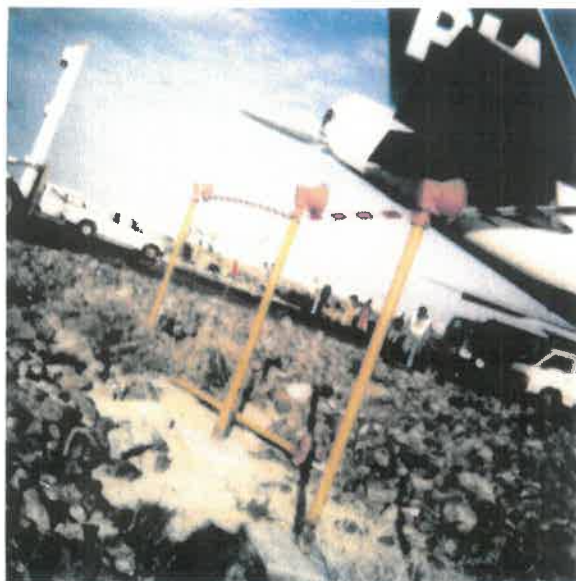
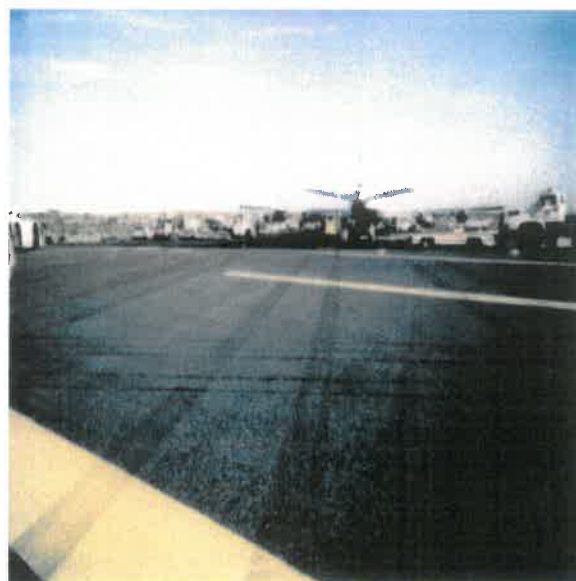
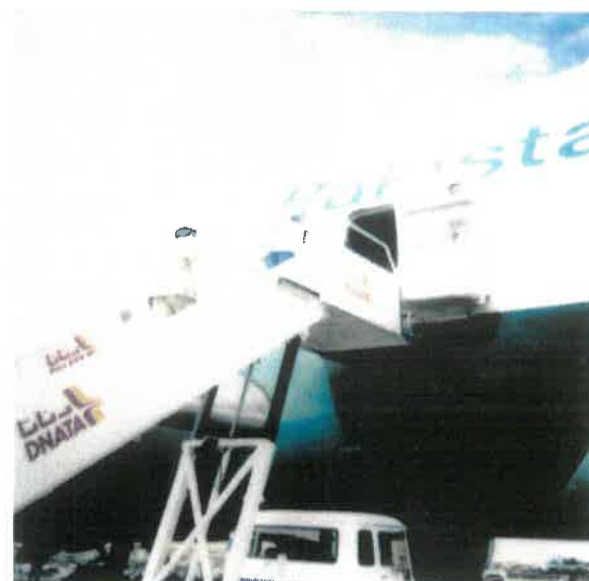
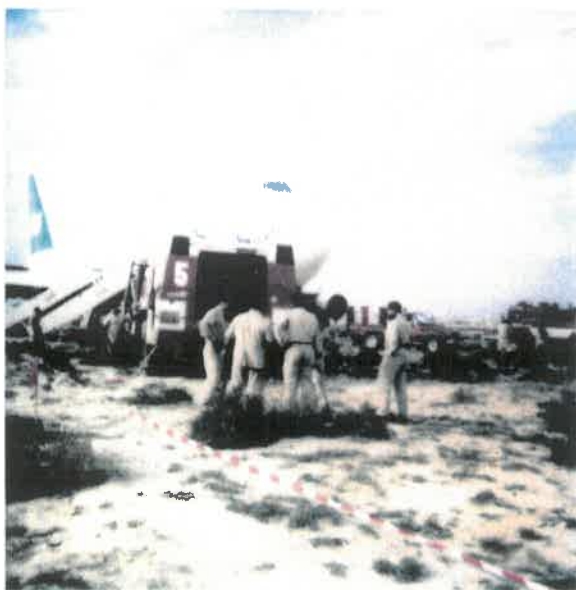
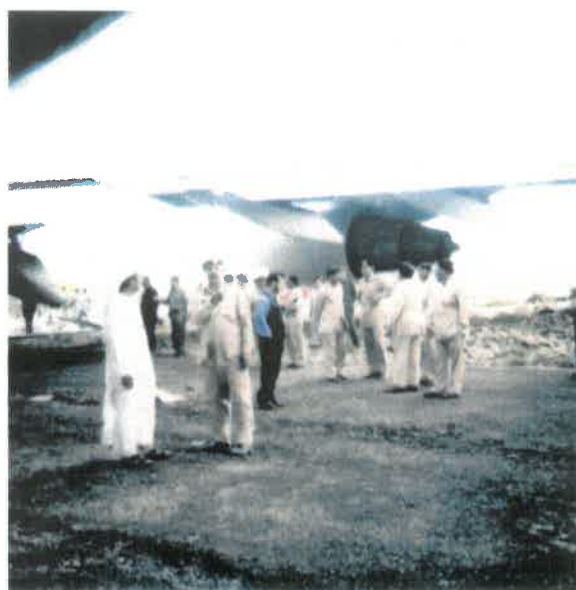
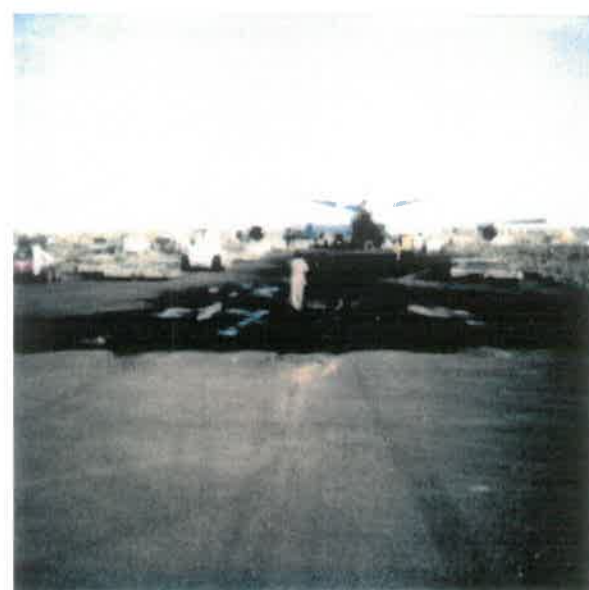
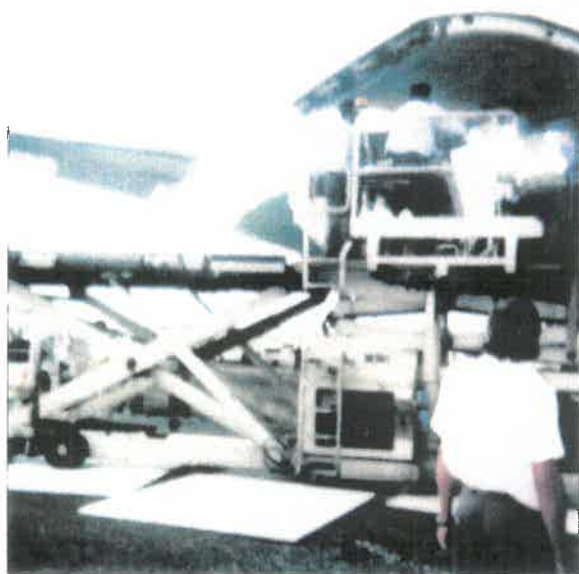
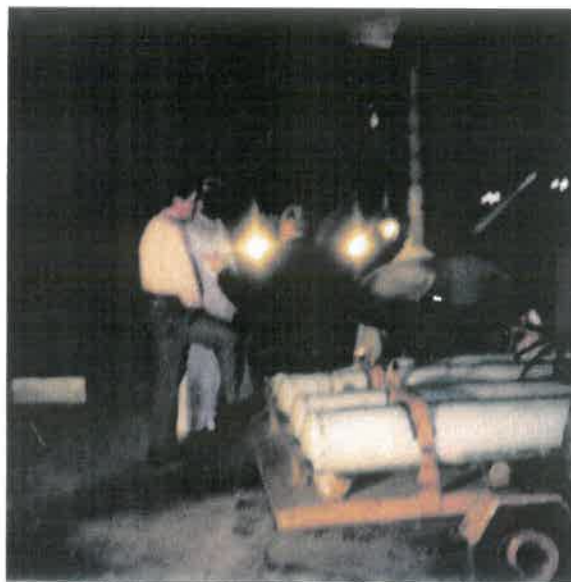
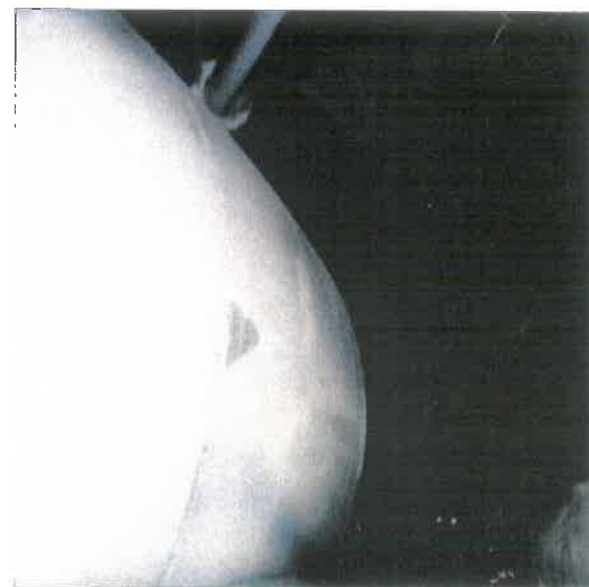
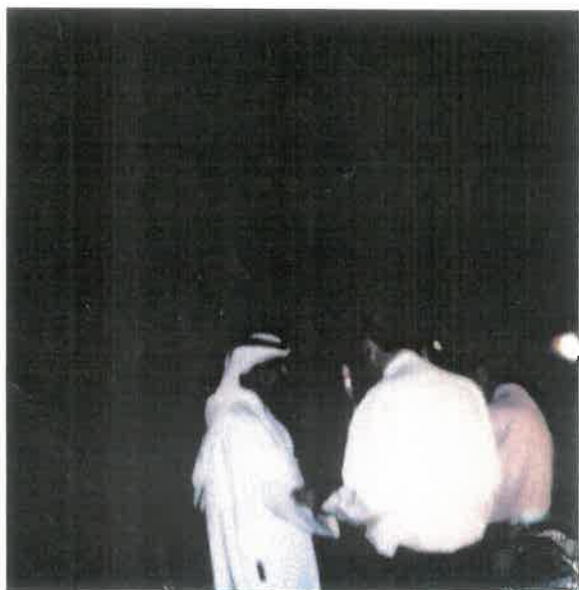
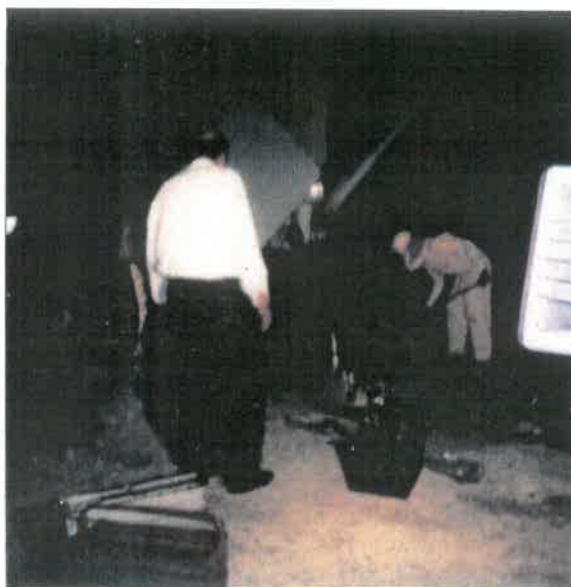
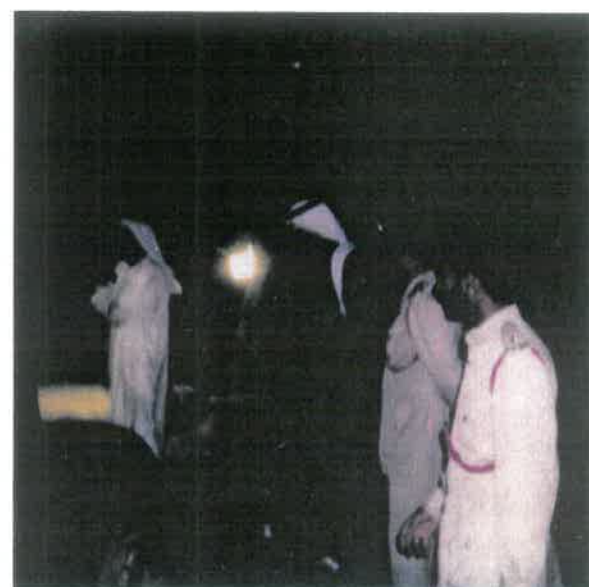
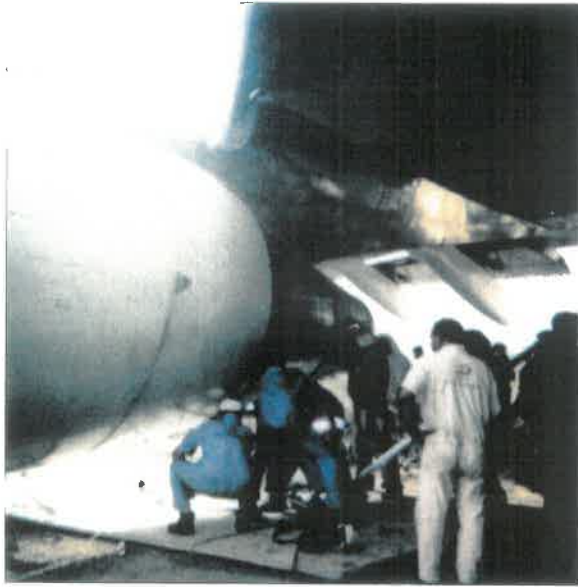
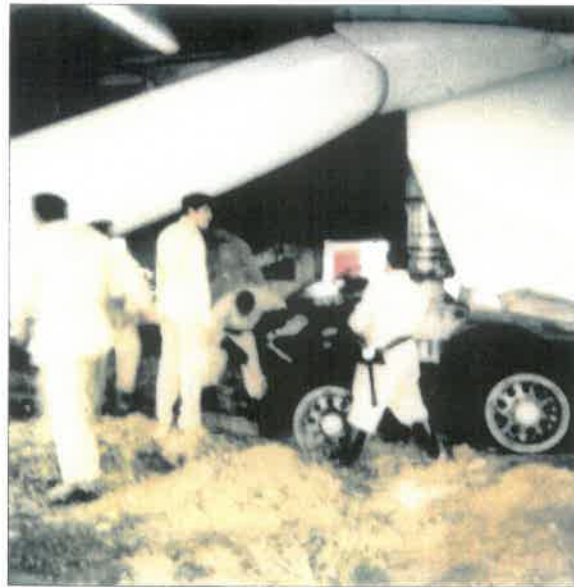
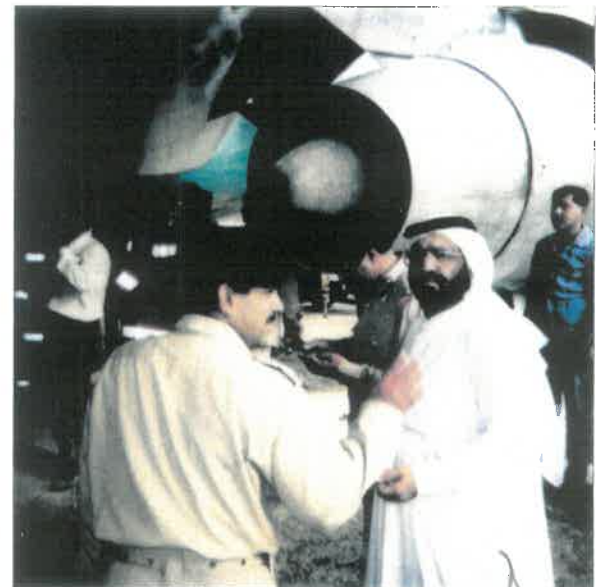
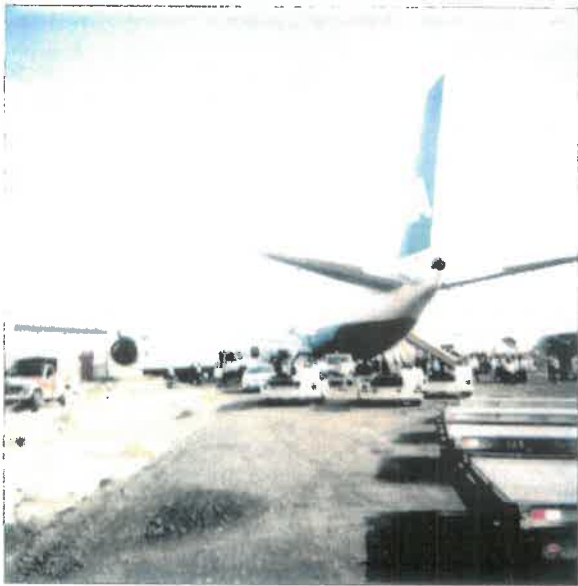
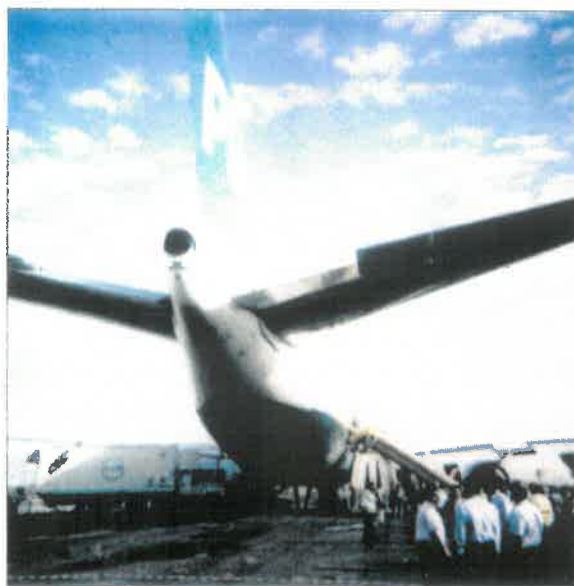
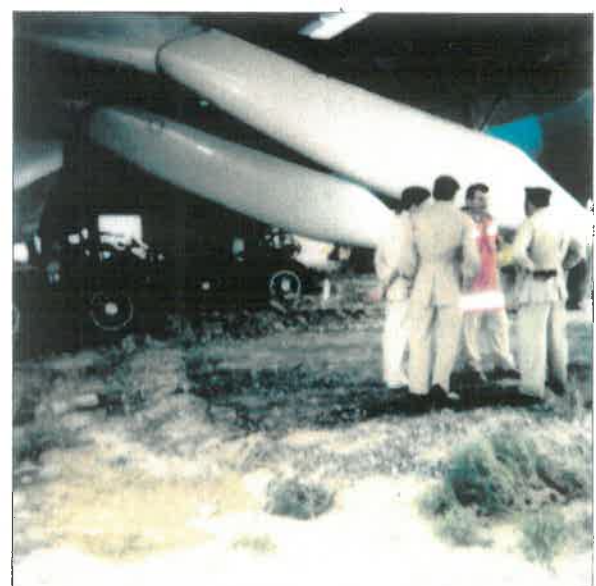
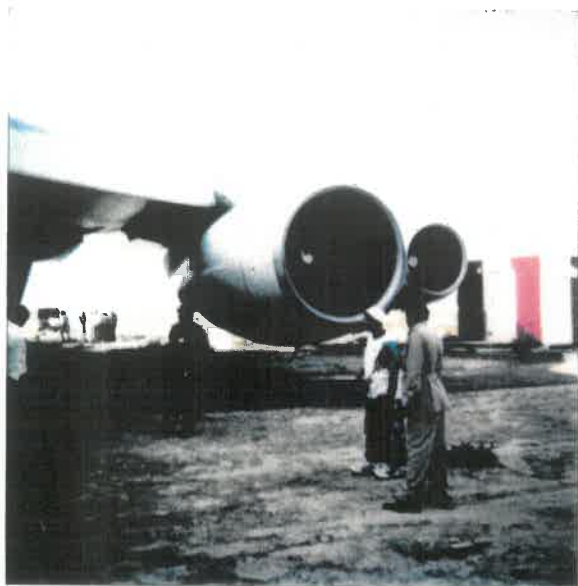
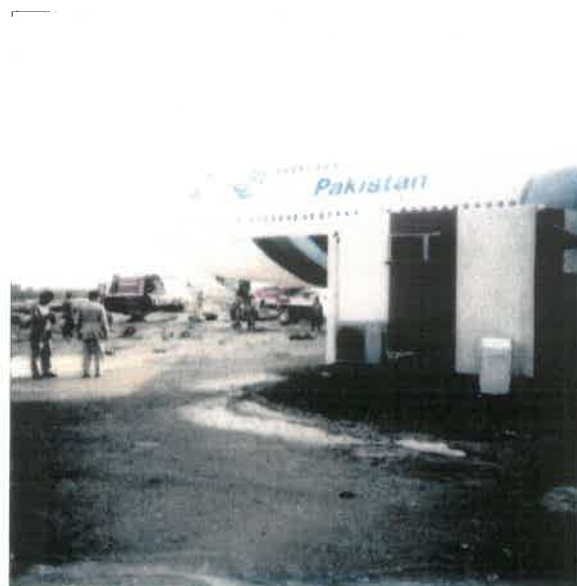
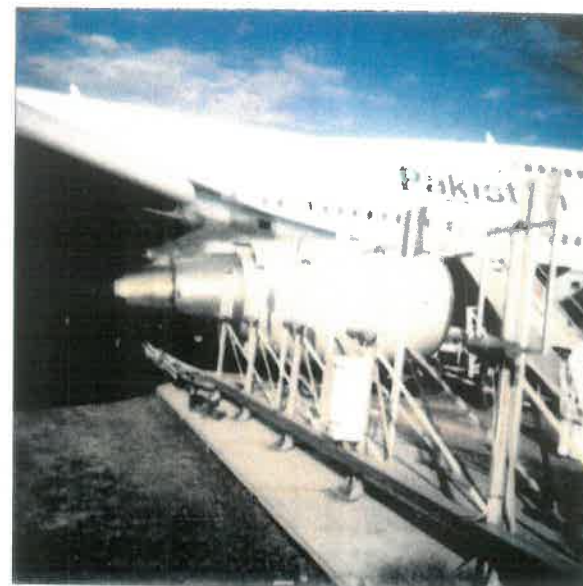
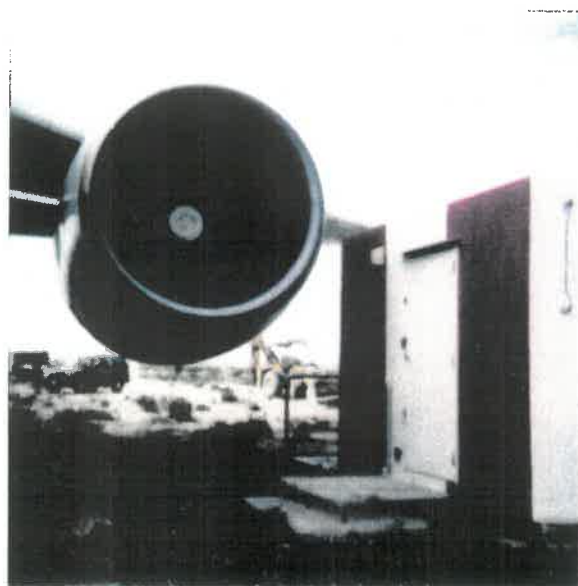
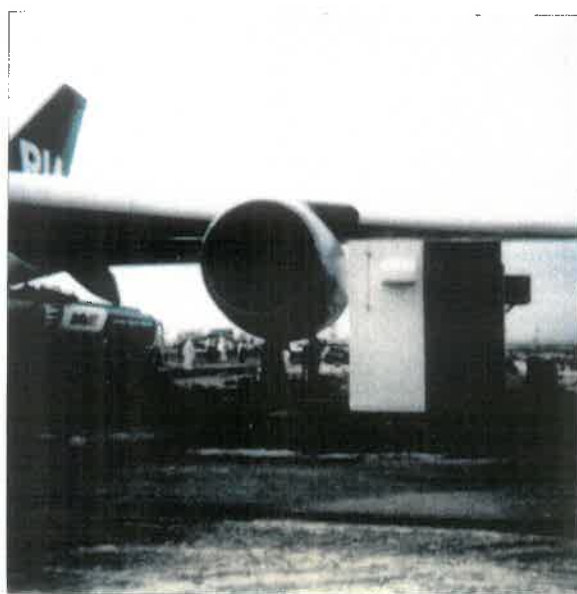
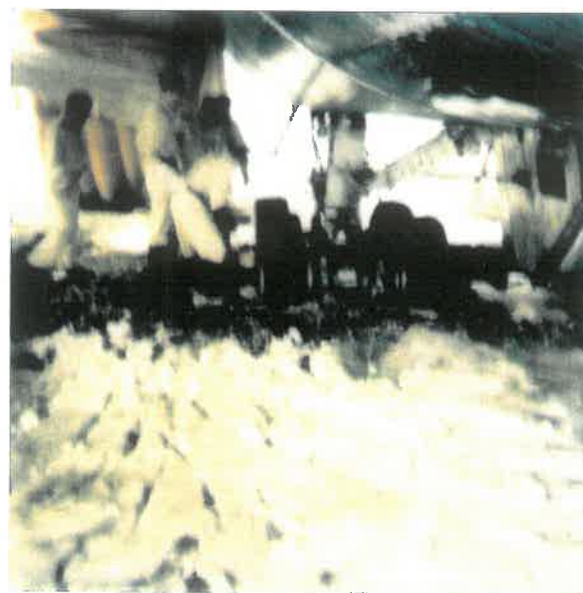
- A. Dubai International Airport Runway Diagram.
- B. Aircraft Overrun Diagram.
- C. Door Emergency Control Diagram.
- D. Aircraft Overrun Photographs.
- E. Airport Crash Reference Map.
- F. Aircraft Exit Reference Locations.

Two runway edge lights were damaged. The ILS Localizer electronic transmitter and fence lighting were damaged.

4.8.2.1 Engine intake nose nacelle casing, the interior casing and fan blades were damaged. The foreign intake damage occurred as the aircraft left the runway and penetrated the localizer fence.
