## **FINAL INVESTIGATION REPORT**

### **SERIOUS INCIDENT TCAS-RA**

**SAUDIA AIRLINE FLIGHT SVA792 AIRBUS 330-343  
AIRCRAFT REG. NO. HZ-AQ18 (OERK TO OPPS) AND  
MILITARY AIRCRAFT ON 05-03-2024**

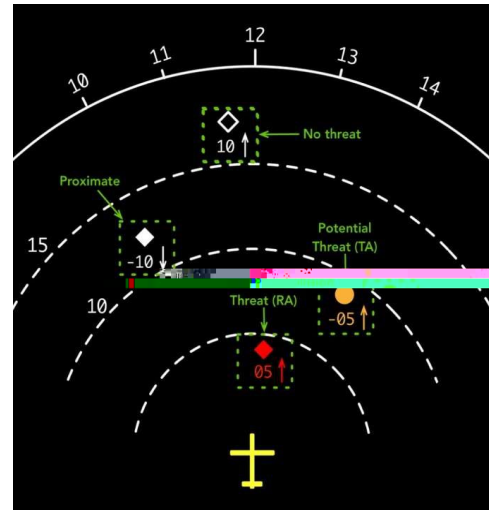
Figure 10 Traffic Display

**1.18.3.4.** Solid yellow or amber circle – for intruders (i.e. aircraft which trigger a TA).

**1.18.3.5.** Solid red square – for threats (i.e. aircraft which trigger an RA).
