**PAKISTAN CIVIL AVIATION AUTHORITY**  
**(SAFETY & INVESTIGATION BOARD)**

**SERIOUS INCIDENT TO M/S. ASSL  
CESSNA F-406 AIRCRAFT, REG. # AP-BFK  
ON 15 DECEMBER 2010 AT SUKKUR AIRPORT**

## INVESTIGATION REPORT

### SERIOUS INCIDENT TO M/S ASSL CESSNA F- 406 AIRCRAFT REG. NO. AP-BFK AT SUKKUR AIRPORT ON 15 DEC 2010

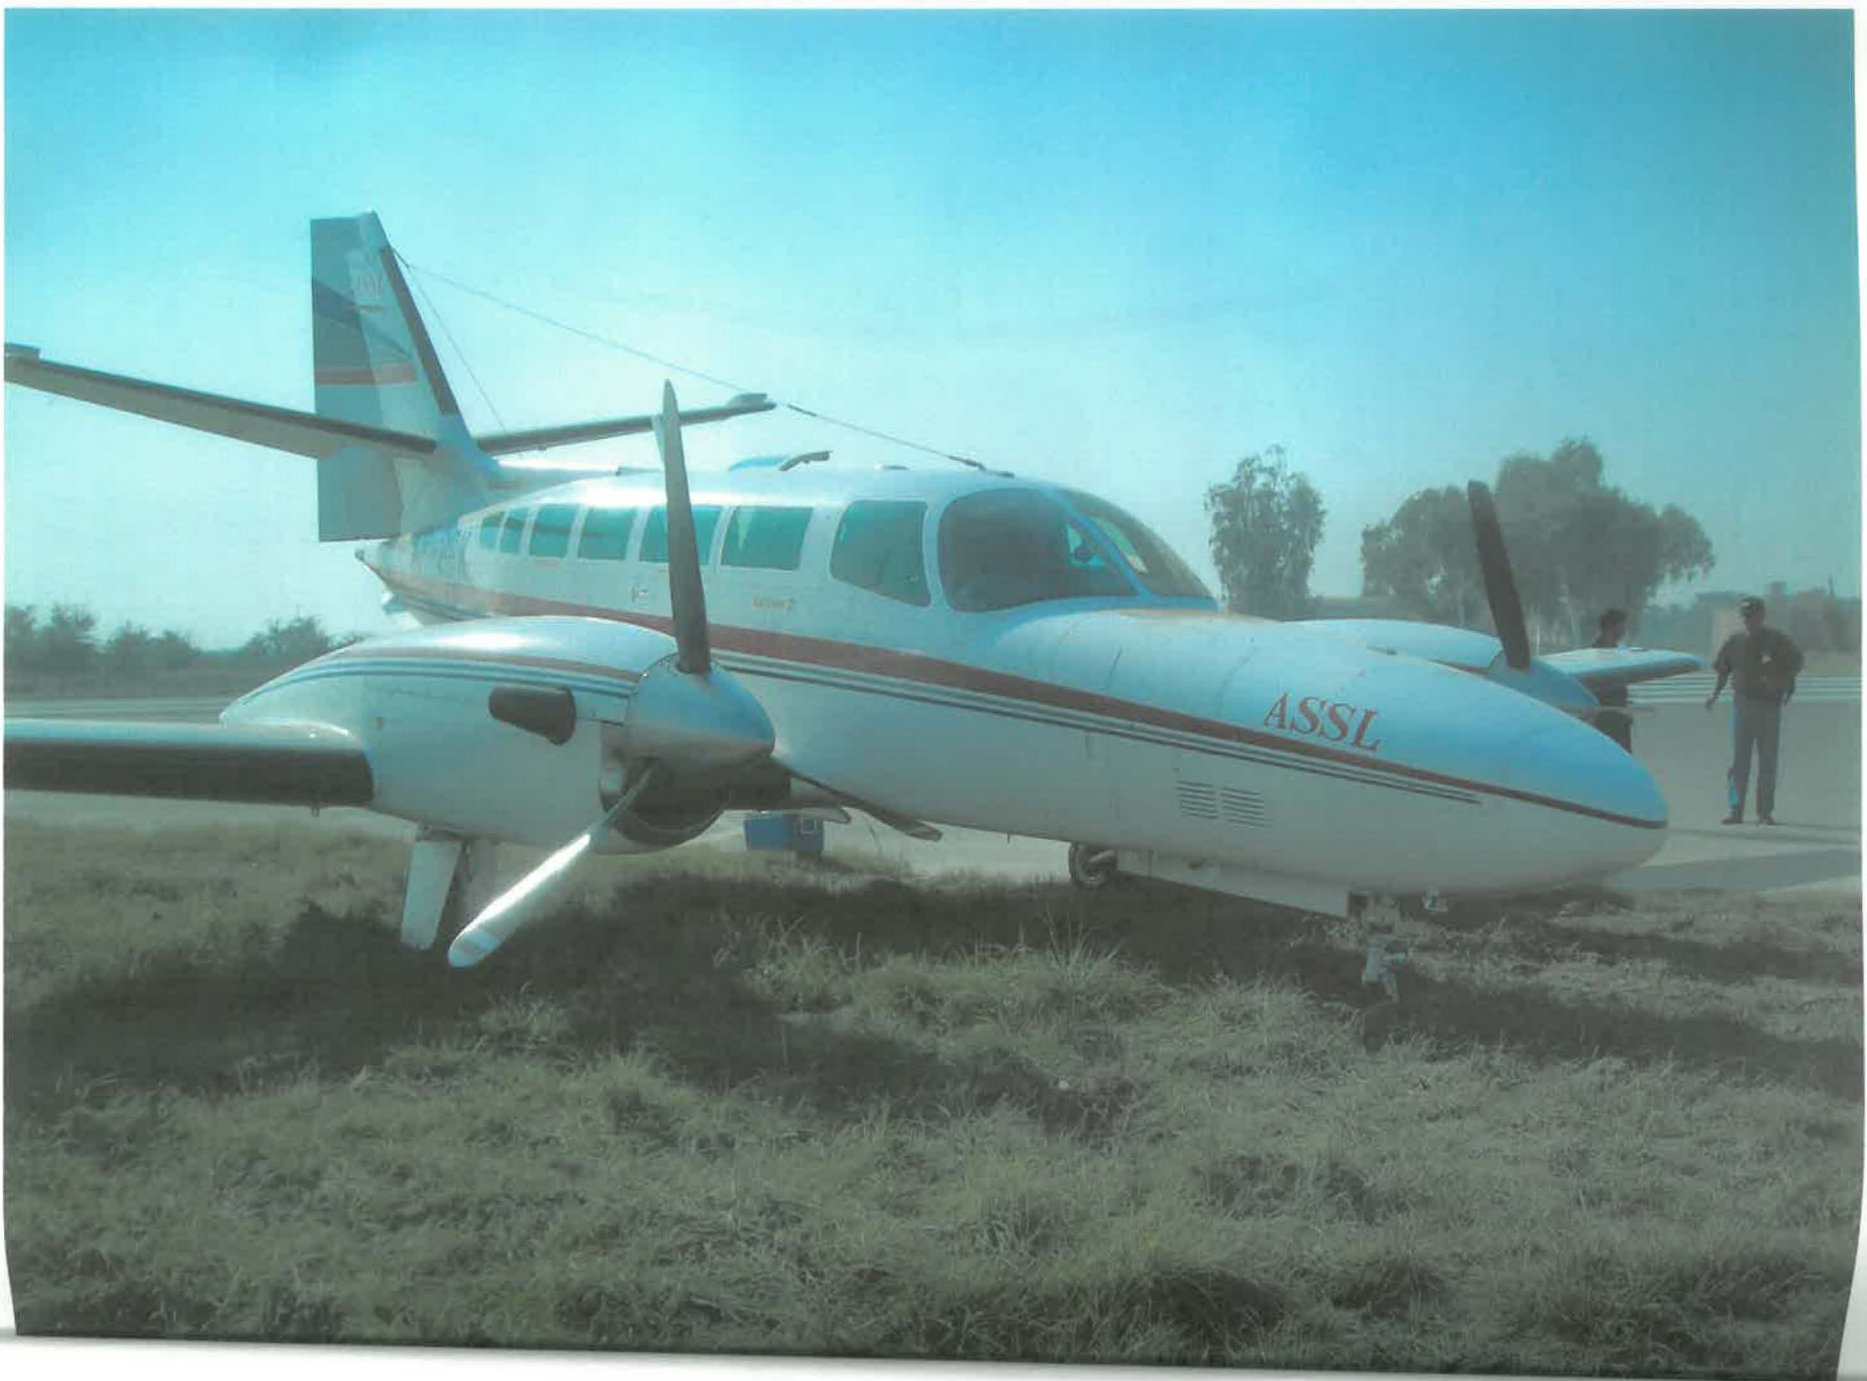
- 1.11 **Wreckage & Impact Information:** Aircraft was found **58 feet** away from the right edge of runway and at about **108 feet** from runway centre line in rough/ unprepared ground. There were tyre marks visible on runway for about **320 feet** before aircraft left prepared surface. Nose leg of the aircraft was found fixed into ground at 108 feet from centre of runway. Detailed wreckage diagram is attached as **Appendix 'C'**.

- 2.1.1 **Aircraft Wreckage Analysis:** After the occurrence the survey of incident site was conducted. The important signs / rubbing marks of tyres on the runway and other related evidences were preserved through digital photography. The damaged parts were examined with a view to establish cause/s of incident. Nose leg of the aircraft was found fixed deep into ground at 108 feet from centre of runway. However, it was revealed that the damages caused to aircraft were due to aircraft going off runway on unprepared surface.
